PREVOST

WARRANTY BULLETIN

WB23-39

DATE:	November 2023	SECTION:	18 BODY
EXPIRATION:	November 2025		
SUBJECT:	MODIFICATION OF THE WIPER MECHANISM ACCESS HATCH SEAL

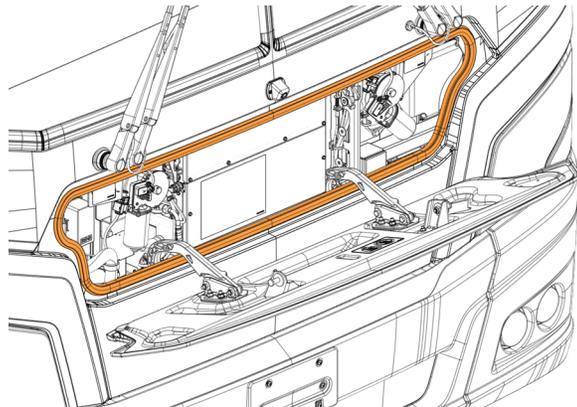
On the vehicles affected by this bulletin, wiper mechanism access hatch seal needs to be modified to avoid water seepage into the compartment.

3. Localization of the seal.
