WB23-16B

DATE :
 November 2023
 SECTION :
 06
 ELECTRICAL

SUBJECT :
 SOLUTION FOR BATTERY DRAIN ON VEHICLE NOT EQUIPED WITH A PREHEATER

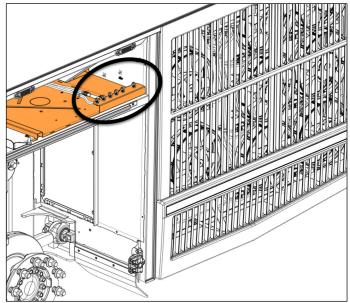
Figure 1: H3-45 Harness location

On the vehicles affected by this bulletin, unplug connector CSX1 and CSX3 to prevent battery drain. This bulletin applies to vehicles not equipped with a preheater.

2. Unplug connector CSX1 and CSX3

3. On connector CSX1 install cap 564069. On connector CSX3 install cap 564660.

4. Secure harness with cable ties 504637 (4x).
