Date	Expiration	Release	Page
11.2018	12.2028	11	2(12)

DESCRIPTION

For the vehicles **on which a notification** for SP18-35 **exists**, perform the following checklist and operations. It has been determined that these vehicles had the code (DTC) P20EE activated.

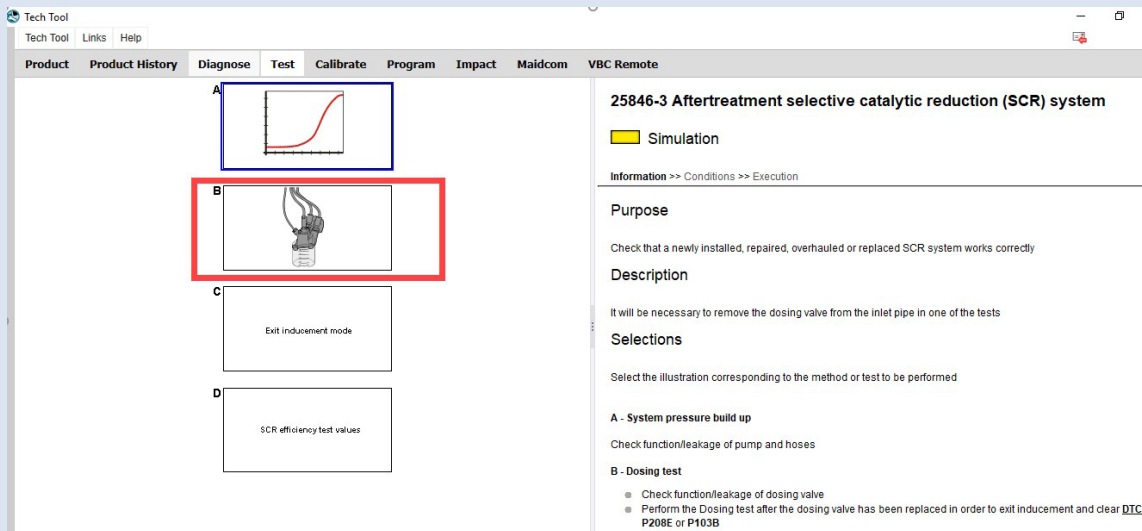
6 Remove DEF doser, perform the dosing test (operation 25846-3 option B) and record the results below.

Expected values: small dosing: 49 - 60 ml

large dosing: 196 - 240 ml

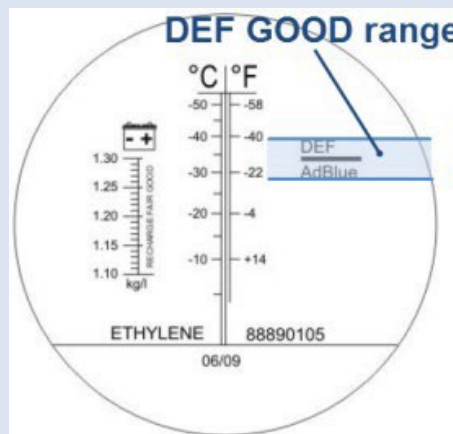
7 Test the concentration of DEF and record the result below. Tool: refractometer # 88890105.

Apply a drop of DEF on the viewer of the refractometer. If the level is above the word "DEF" or below the word "AdBlue" the DEF is contaminated. If no level is shown, it may indicate chemical residue, such as pure water or diesel fuel.
