**MAINTENANCE
INFORMATION**

MI24-42A

| SUBJECT : | SD Card Version Update for Digital Passenger Clock - Resolving Time Zone and Format Switching Issues | |

Revision: A

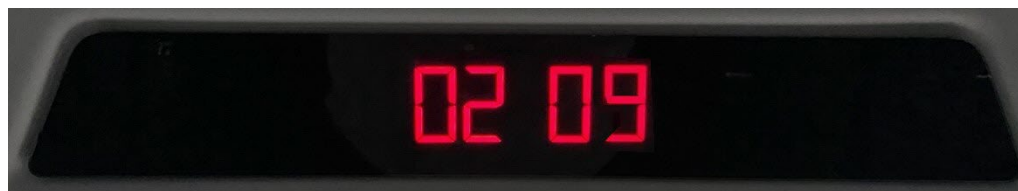
4. At the same time, let a second person from inside the vehicle check the following sequence on the clock screen:
 - All LEDs will light up.
 - The Firmware version will be displayed. It should read **00 12**.
 - The SD card version will be displayed. It should read **02 09**. If it is an older version, proceed to updating SD card version.

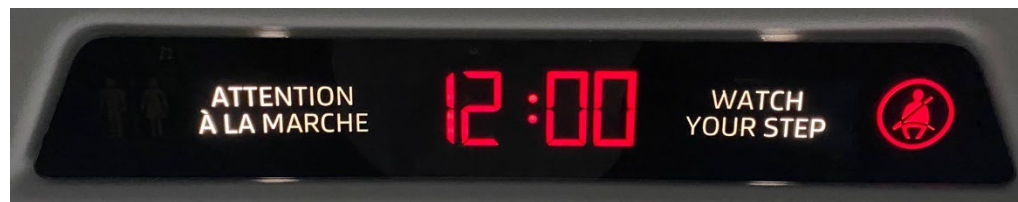
- The clock will display 12:00. Then, the time format will automatically update to 12-hour format in USA and 24-hour format in Canada. The time will also update automatically to the correct time zone.
