Warranty Bulletin

WB25-81A

Revision: A

VEHICLE ELECTRICAL CENTER CONNECTORS CLEANING 9700 (B13R)

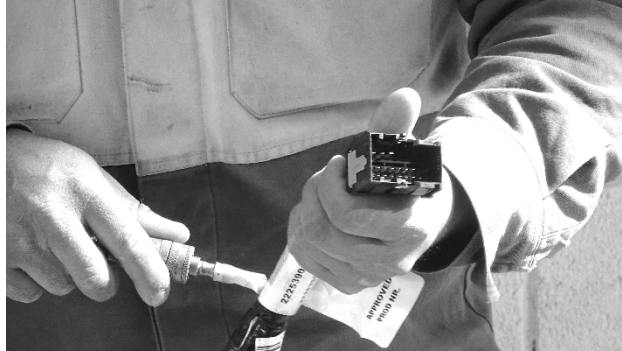
On the vehicles affected by this bulletin, metal shavings may contaminate the VEC connectors, leading to short-circuited control signals. To prevent accidental activations of the fire extinguishing system, the connectors in the front electrical compartments must be thoroughly cleaned.

- 7) Use compressed air to blow away any metal shavings accumulated on the pins or the connectors.

- 8) Clean the EC bridge harness to remove any metal shavings from the connectors housing.
