Warranty Bulletin

WB25-80

HYDRAULIC FAN SENSOR HARNESS RELOCATION 9700 (B13R)

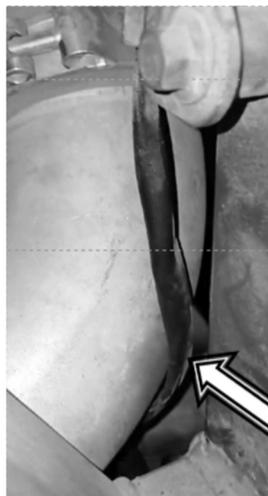
On the vehicles affected by this bulletin, reroute the engine cooling fan speed sensor harness to avoid damage.

- 3) Cut cable-ties and remove the harness from its routing below the lower intercooler connection.
