Revision: A Updated quantity of part 3170224 in the kit

05-21-2025

HYDRAULIC FAN SENSOR HARNESS RELOCATION 9700 (B13R)

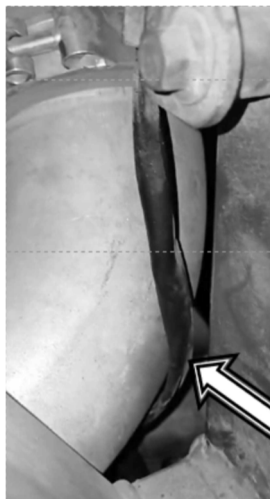
- 3) Cut cable-ties and remove the harness from its routing below the lower intercooler connection.
