PREVOST

Sr00-17A

SUBJECT: UPPER A-ARM BALL JOINT INSPECTION ON

INDEPENDENT FRONT SUSPENSION

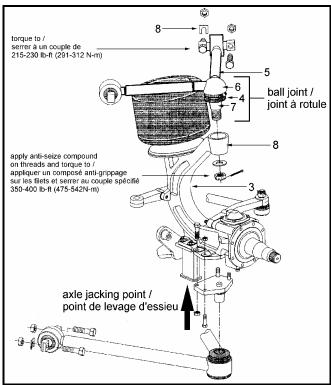
FIGURE 5: INDEPENDENT FRONT SUSPENSION DETAIL

On the above mentioned vehicles, it is necessary to inspect the ball joint on the upper A-Arm. During normal use, on the high mileage vehicles (over 300 000 miles), it is possible that the ball joint sealing boot be perforated and grease leaks may occur. A joint with a perforated boot will have its life reduced and must be replaced. You must make an appointment with the nearest Prévost service center in order to have your vehicle inspected.

- 6. Check the boot (figure 5) for perforations or grease leaks.
 - I. If sealing is perforated but there are no traces of grease contamination or rust, replace sealing boot only (Partie B).

II. If sealing boot is perforated, there are traces of grease contamination or rust and the socket • (figure 5) is not in good condition (see next step), the upper A-arm • has to be replaced (Part C).

- 7. Locate the ball joint (figure 5).
- 8. Using a pry bar underneath the A-arm, apply an upward force as to separate the ball from the socket.
- 9. If there is a play between the ball and the socket, the upper A-arm has to be replaced (Part C). Take note that a play of $^1/_{32}$ to $^1/_{16}$ is normal and acceptable. If the play is normal and the sealing boot is in perfect condition, no replacement or repair is needed. See added supplement at the end of this bulletin.

- 6. Remove the cotter pin and partially unscrew the ball element retaining nut (figure 5). With the use of a hydraulic jack or a puller, extract the ball element from the conical sleeve (figure 5). To facilitate extraction, change the position of the A-arm by changing the height of the vehicle.

- 7. Remove hose clip and clamping ring fixing the boot then take off sealing boot.
- 8. Fill sealing boot with 20 grams of Molykote Longterm 2/78 grease. Make sure that sealing boot is properly seated in the socket retaining groove and then fit hose clip and clamping ring.

- 9. Insert the ball element in the conical sleeve.
- 10. Apply anti-seize compound on threads and torque to 350-400 lb•ft (475-542 N•m). Insert the cotter pin.
