PREVOST

SAFETY RECALL

SR25-13

DATE:	June 2025	SECTION: 16 SUSPENSION
SUBJECT:	RETORQUE IFS LOWER CONTROL ARM BOLTS

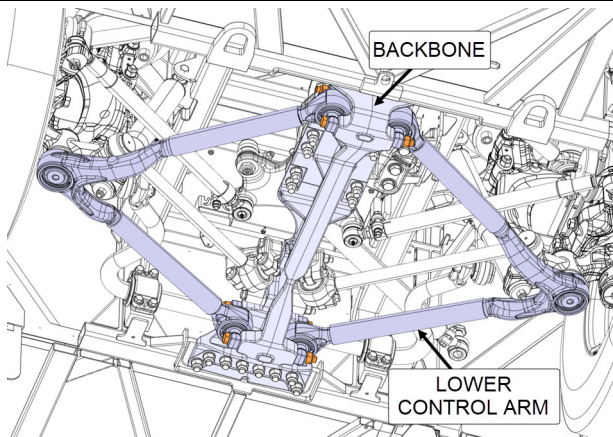
2. Locate the four bolts securing the lower control arms of the front suspension to the backbone.

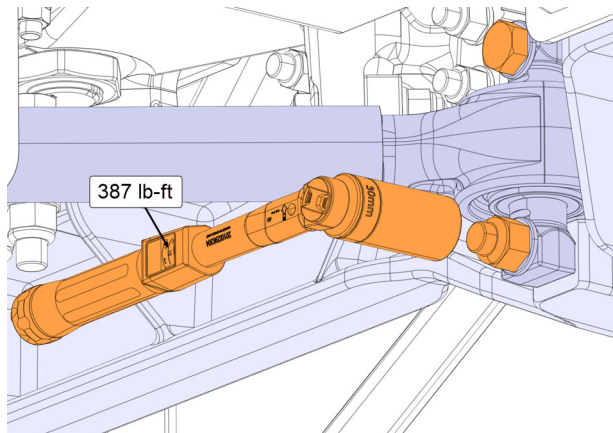
On vehicles affected by this recall, the bolts securing the front lower control arms may not have been properly tightened, potentially resulting in the separation of the control arms.

3. Torque each bolt to **387 lb-ft**.
4. Apply red torque seal mark.
