WARRANTY BULLETIN

WB25-20

DATE :	July 2025	SECTION :	18 BODY
EXPIRATION:	July 2027		
SUBJECT :	PARCEL RACK BOLTS INSPECTION AND RETIGHTENING

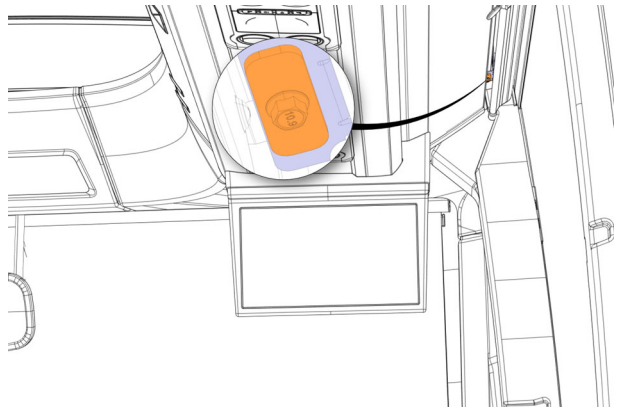
1. Locate the bolt securing the first curbside parcel rack to the ceiling, positioned next to the pillar.

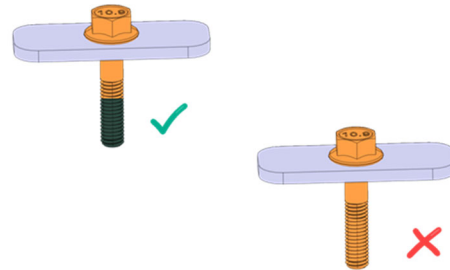
3. Check the presence of blue threadlocker on the screw.

- If present, perform steps 4 to 6 to complete this bulletin. No further action is needed.
- If missing, perform steps 4 to 6, then refer to **PART 2** to retighten all the bolts.

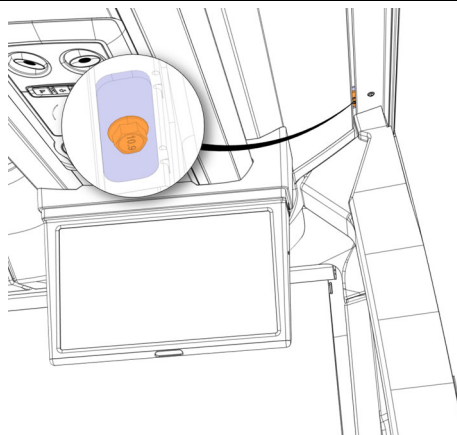
1. Locate the bolt securing the first curbside parcel rack to the ceiling, positioned next to the pillar.

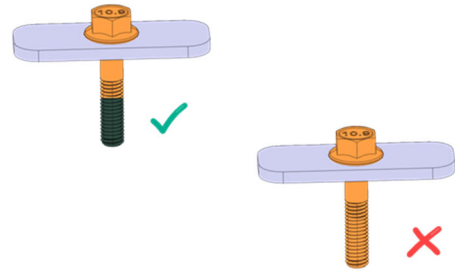
4. Check the presence of blue threadlocker on the screw.

- If present, perform steps 5 to 8 to complete this bulletin. No further action is needed.
- If missing, perform steps 5 to 8, then refer to **PART 2** to retighten all the bolts.

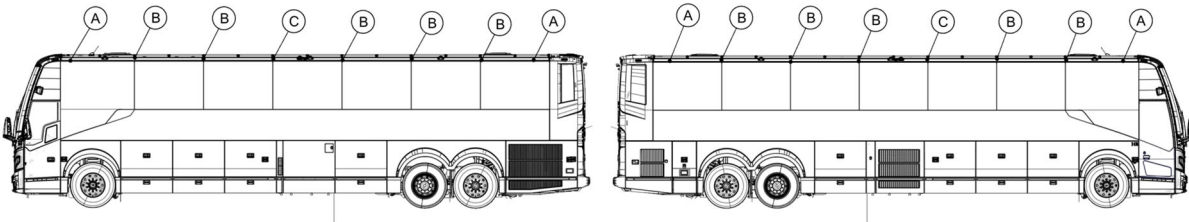
H3-45 COACHES WITH ROLLER BLINDS WITHOUT WHEELCHAIR LIFT

1. Locate the bolts securing parcel racks to the ceiling on the window side.
