PREVOST

WARRANTY BULLETIN

WB15-10

DATE :	APRIL 2015	SECTION :	01 - Engine
EXPIRATION:	APRIL 2017		
SUBJECT :	ENGINE OIL FILL FLEXIBLE TUBE INSPECTION AND REPLACEMENT

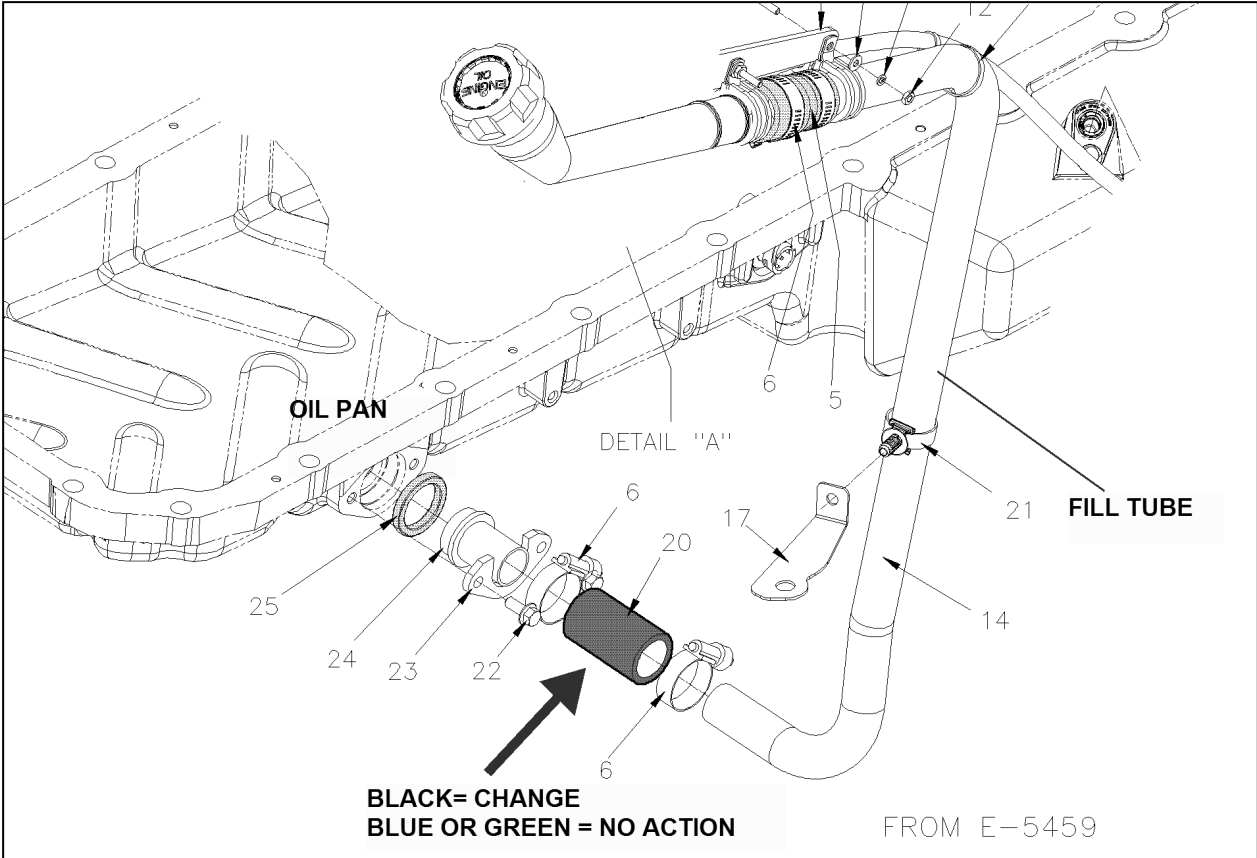
Figure 2

On the vehicles affected by this bulletin, inspect the lower oil fill tube flexible tube. If it is made of black material (EDPM), replace tube. Green and blue silicone hoses are accepted.

- A. Open curb side engine compartment door. (Item 2, Fig. 1)
- B. Visually inspect the lowest section of the oil fill tube. (Fig. 2) The hose connecting the steel tube to the oil pan should be green or blue. (Fig 3 & 4)
- C. If hose is black, perform replacement according to Step **B** below. Otherwise, this is the end of the bulletin.
