PREVOST

WARRANTY BULLETIN

WB19-11 A

DATE :	June 2019	SECTION :	06 ELECTRICAL
EXPIRATION:	June 2021		
SUBJECT :	ISM IMPROVEMENT (VEHICLE PROGRAM UPDATE)

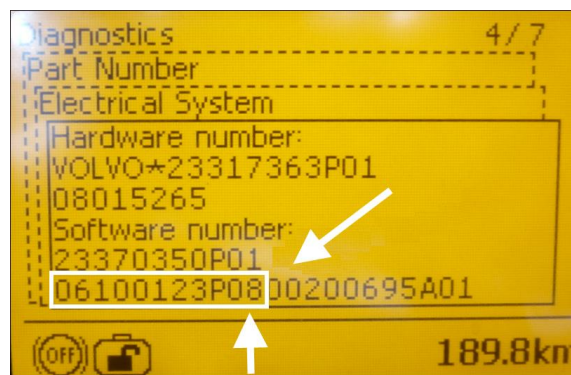
Figure 4

- The DID shows the software number (program number) and the actual revision number just after the letter "P" for the vehicle. The example in Figure 4, the program number is 06100123 and the actual revision number is P08.
- Note the program number and the revision number.
