SAFETY RECALL

SR23-82

02-01-2023

BAD GPS CONNECTION AT THE VECU CONTROL UNIT
9700 (B13R)

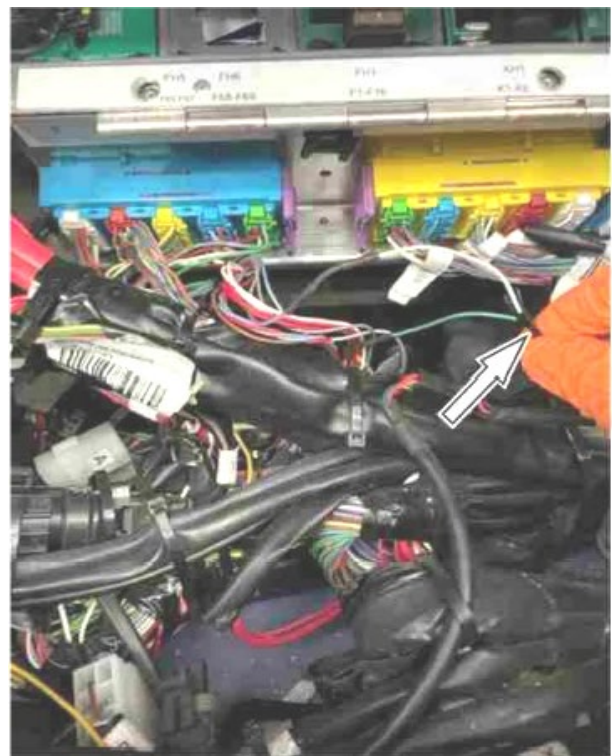
- The bad digital signal connection of the GPS is located between VECU (A17) and the throttle position sensor (B25), therefore; look for spliced GPS wires near the IB9 connector of the power distribution center in the vehicle electrical center compartment.

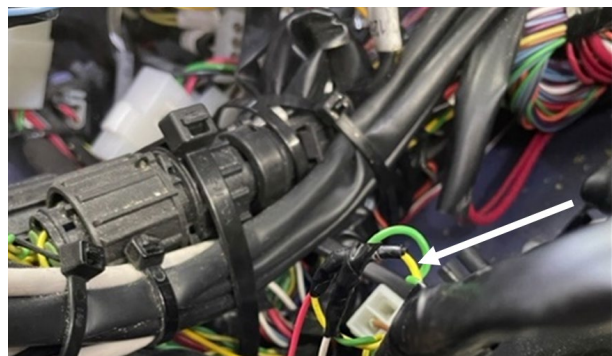
The digital signal of the GPS can be spliced to the wires located at PIN9, 10 or 11 of the IB9 connector as seen below.

- Once the GPS digital signal is located, remove it from the IB9 connector corresponding wire. This wire of the IB9 connector must be repaired to ensure proper "interference free" signal so the throttle response is back to normal operation. This will also resolve the VECU communication problem with the CAN network.
- Repair the wire using supplied butt splice connector and shrink tubing (solder the connection).

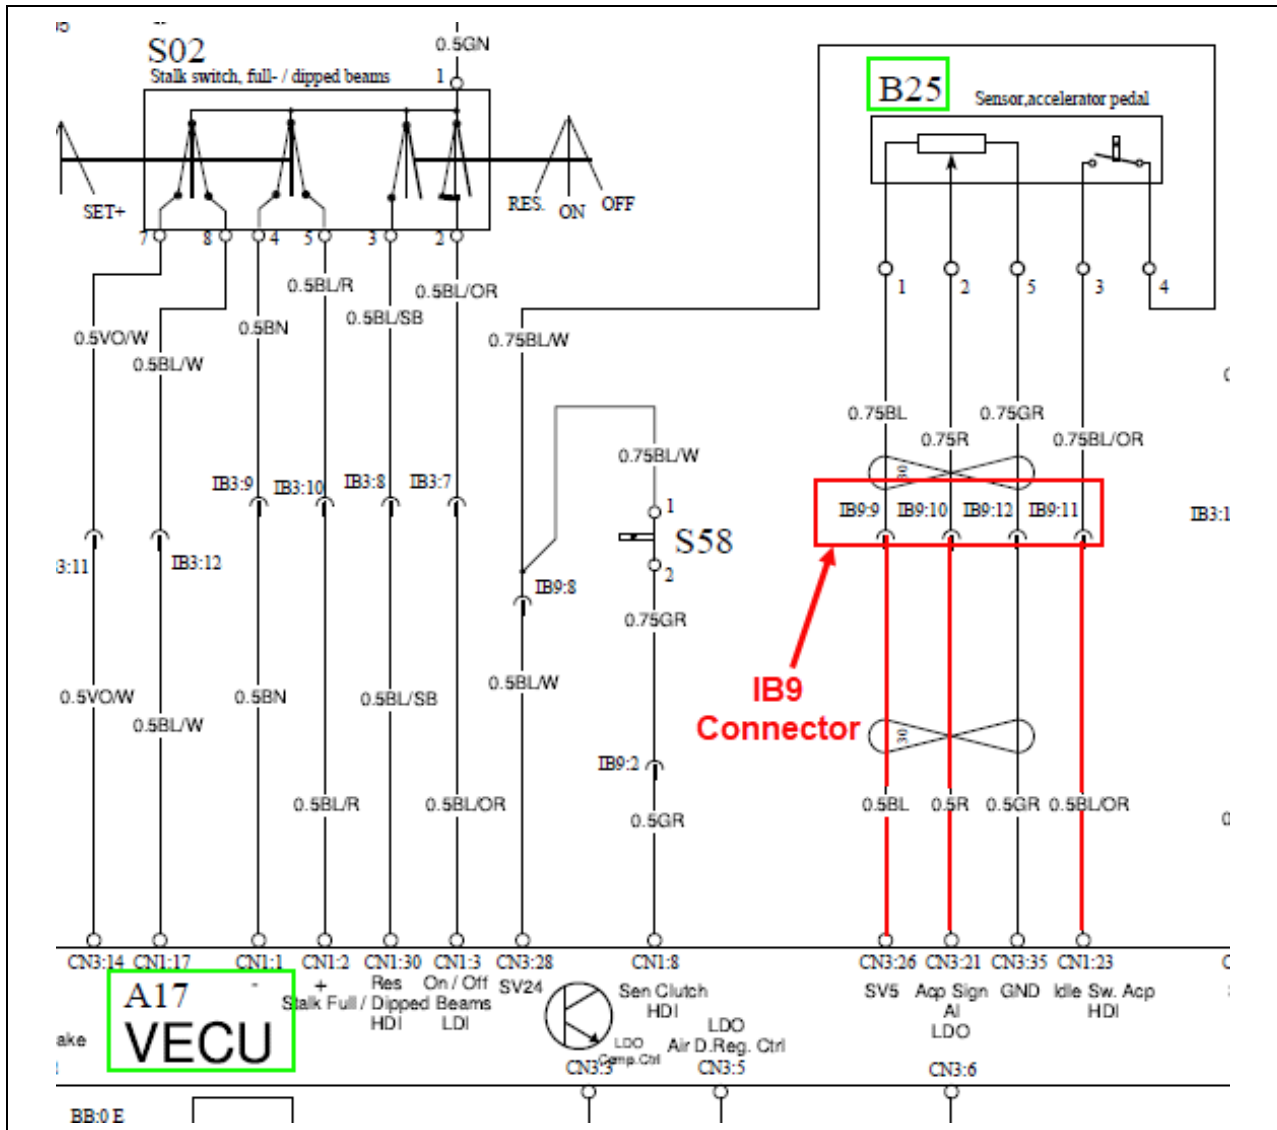
REF BA WIRING DIAGRAM

Do not remove or modify other GPS connections. The problem only exist at the digital signal connection.

- Connect the GPS negative signal to the VECU.
 - The GPS must send a negative LDI signal(-) from the power distribution center located in the vehicle electrical center compartment to the VECU vehicle control module.
 - To send the correct GPS signal, the GPS signal wire must be connected to PIN12 of the power distribution center BB13 connector (BB13:12). This connection will send the signal to PIN17 of the VECU control module CN3 connector (CN3:17 see wiring diag. BA).
