SAFETY RECALL

SR24-05

DATE :	January 2024	SECTION :	06 ELECTRICAL
SUBJECT:	RETIGHTEN FUSE-HOLDER NUTS F199

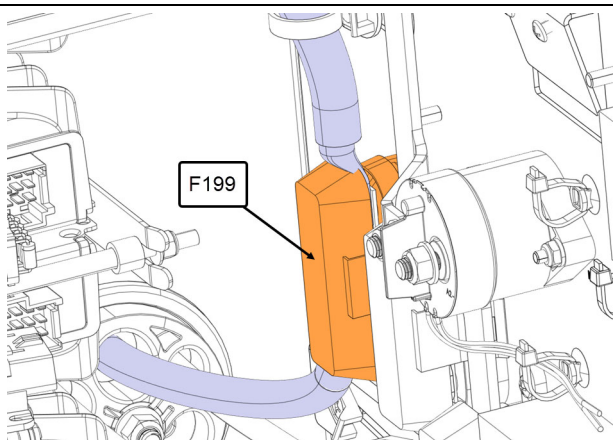
5. Locate fuse holder F199 inside rear junction box.
