PREVOST

WARRANTY BULLETIN

WB24-32

OUTISIDE MIRROR HEAT SWITCH - WIRING

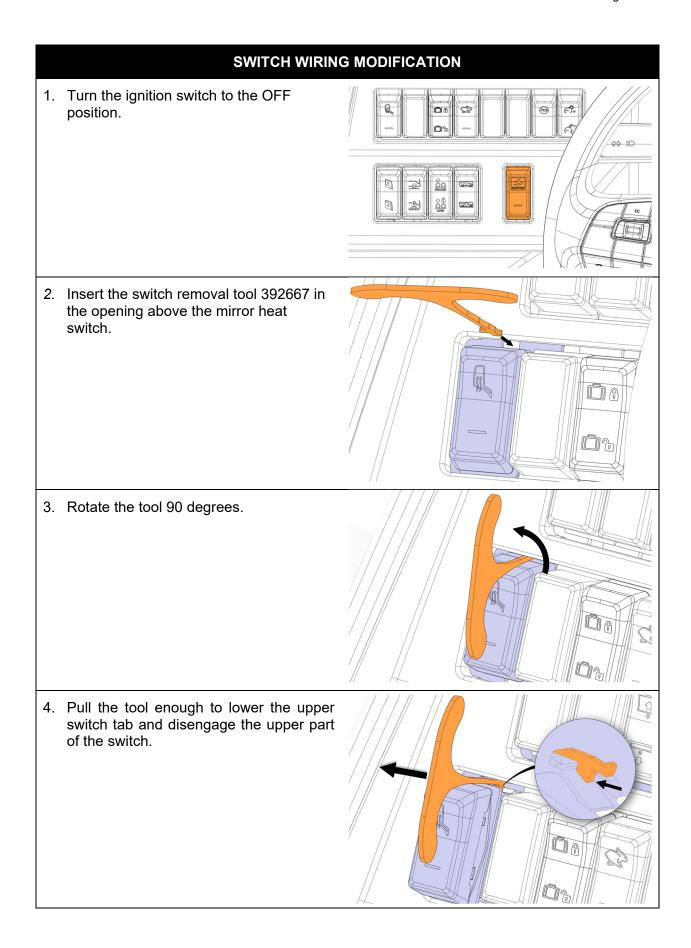
On the vehicles affected by this bulletin, the outside mirror heat function may be not working properly due to swapped wires on the switch connector.

5. Insert the tool in the opening below the mirror heat switch and repeat the process to disengage the lower tab of the switch.
