PREVOST

**MAINTENANCE
 INFORMATION**

Mi12-04C

DATE : MARCH 2012	SECTION : 04 - Exhaust
SUBJECT : WIRING - ACM GROUND AND SUPPLY, DPF TEMP SENSORS, VECU SUPPLY

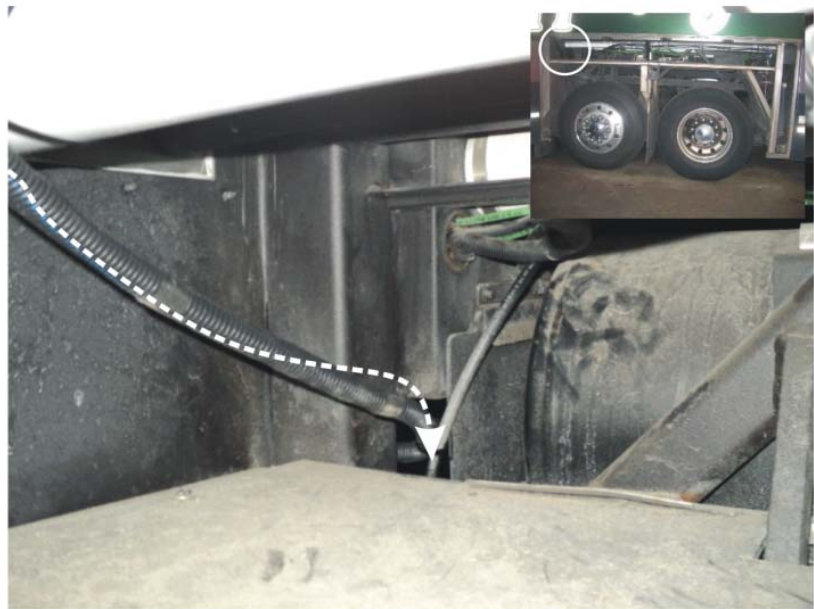
In engine compartment. Accessible through rear access panel inside the coach, close to the restroom. Looking towards the left.

15. Run harness from the tag axle area (previous step) up to the back of the coach following main harness.

Ground cable (black) should be run to the rear electrical compartment.

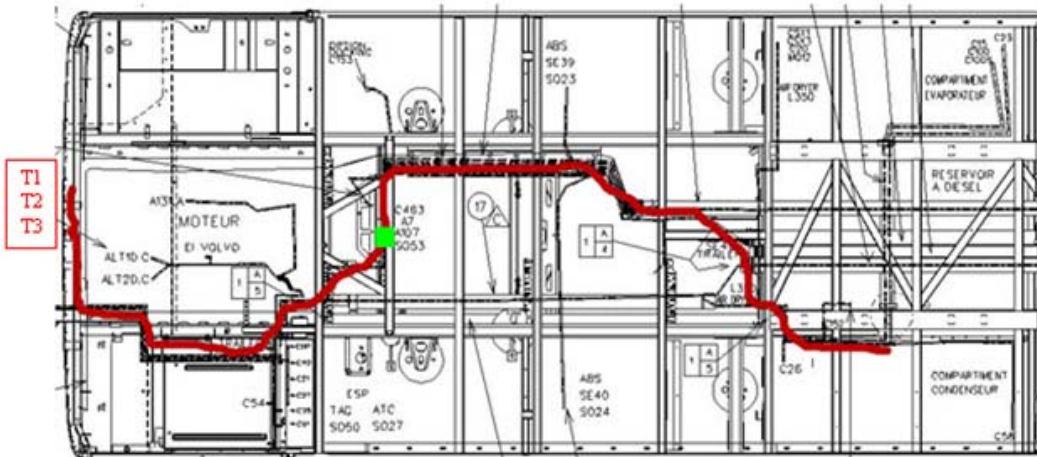
Top view of suggested harness routing. As a reference, position green tape on transversal cable support above transmission. Routing is realised from this point up to DPF and up to ACM in condenser compartment.

1. Place green tape on transverse cable support above transmission.

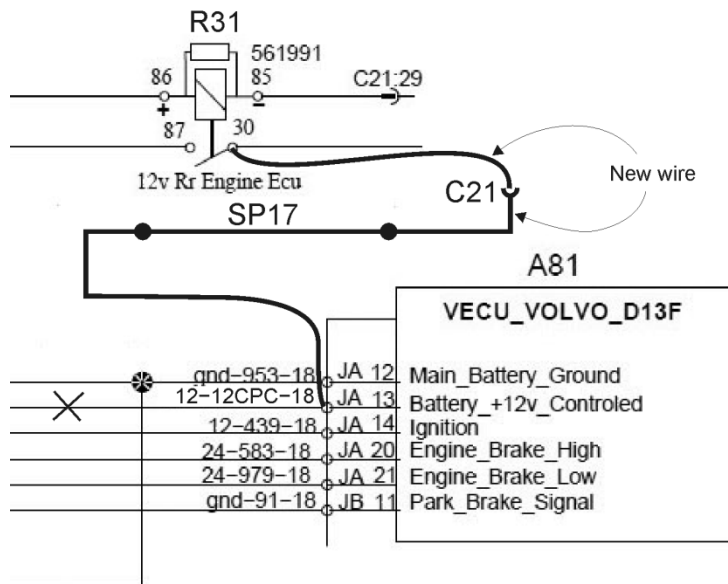
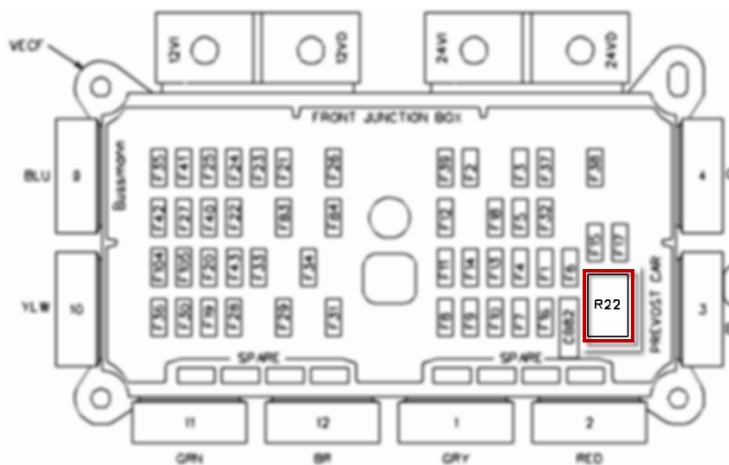
INSTRUCTION PART "B" - H3-45 AND H3-45 VIP

Power supply arrangement to the Vehicle Electronic Control Unit (VECU) may cause recurrent "Vehicle ECU fault" codes in the Driver's Information Display (DID).

1. In rear electrical compartment, locate **R31**
2. Cut existing tab terminal at pin 30.
3. Crimp new wire #562593 and existing 12ECU wire on #562368 tab terminal. Replace at pin 30 of R31.
4. Install #563588 pin and #563603 socket terminal to pass new wire through C21.
5. (Use extractor tool #682321)
6. Splice new wire end with SP17.
#562228 butt splice
#560784 shrink tube
7. Locate SP17 in front electrical and service compartment it is located near C2.
8. Cut wire 12 CPC at VECU JA13.
9. Run a new 12CPC wire from spare wire SP17 to JA13. Install # 562771 terminal and connect.
10. Once completed, remove R22 Relay from VECF as it is now unused.
