## PREVOST

# MAINTENANCE INFORMATION

Mi97-16

**SUBJECT:** Windshield washer system flow increase

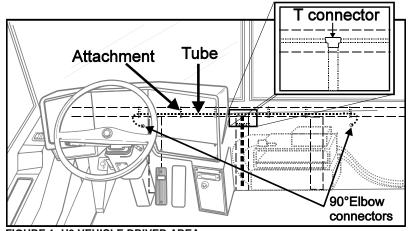
FIGURE 1: H3 VEHICLE DRIVER AREA

In order to increase flow in windshield washer system, the diameter of tubes located between T connector and wipers is increased from 1/8" dia to 3/16" dia.

- In order to access windshield washer tubes, remove front panel located on right side of dash (Fig. 1 & 2).
- 2. Remove all attachment, securing the two tubes located between T connector and wipers.
- 3. Remove the two tubes and the T connector.
