SAFETY RECALL

Sr05-06A

SUBJECT: IMPROPER MOUNTING OF 3 RADIUS ROD

SUPPORTS

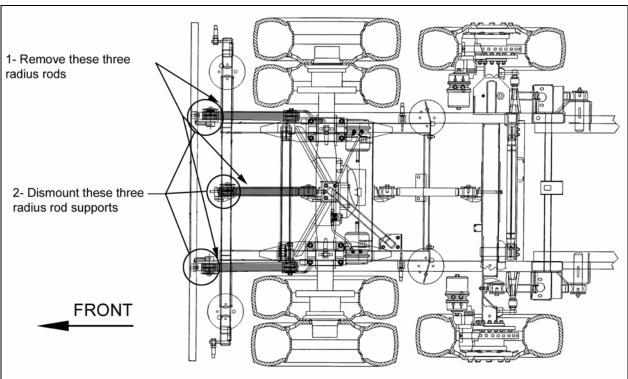
FIGURE 3: REAR SUSPENSION

For the above mentioned vehicles, Prevost Car has determined that a too large quantity of anti-seize compound has been used for mounting the 3 identified radius rod supports. The bolts securing the supports could come loose and the support may eventually detach from the structure. This could affect

vehicle stability and cause a crash. It is necessary to dismount the radius rod supports, to remove all trace of anti-seize compound and to reinstall the supports according to the corrected factory procedure.

- 5. Dismount successively the 3 radius rods identified in figure 3 by flattening the tabs of locking plate and by unscrewing the two bolts directly fastened into radius rod pivot (if needed, refer to maintenance manual).

- 6. Dismount successively the 3 radius rod supports identified in figure 3. Take note of the position and quantity of shims in order to reinstall the components in the same condition as they were to maintain proper vehicle alignment.
