PREVOST

**SAFETY
RECALL**

Sr08-12

DATE : OCTOBER 2008	SECTION : 23-ACCESSORIES
SUBJECT : REPLACING WEAKENED BOLTS ON THE ROOF ESCAPE HATCH

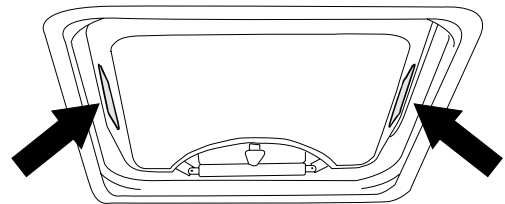
On the vehicles mentioned above, it is **absolutely necessary** to replace weakened bolts on the roof escape hatch. The roof escape hatch manufacturer encountered a quality issue related to the bolt's installed strength. Bolts exposed to higher than normal torques were used in the manufacturing of the escape hatches. Weakened bolts can fracture during opening of the hatch for ventilation. The hatch can detach completely, causing injuries, damages to nearby vehicles and even cause a crash.

1. Open the hatch. To do so, push the escape hatch outwards, pressing with both hands where indicated.
2. Four bolts must be replaced on each hatch.
3. Remove the first bolt and put aside. You will need a screwdriver bit Torx T40 or Phillips #4 depending on the existing bolt type.

If necessary, remove old Loctite™ residues in the threaded hole. To do so, use a 5/16X18 tap.
