PREVOST

**SAFETY
RECALL**

Sr11-10

DATE : MARCH 2011	SECTION : 03-FUEL
SUBJECT : REPLACEMENT OF THE FUEL TANK SUPPORT

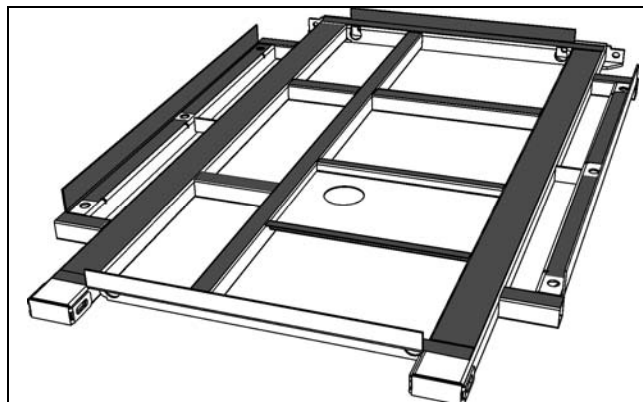
APPLICATION OF SELF-ADHESIVE NEOPRENE FOAM (dark area)

3. Apply self-adhesive neoprene foam (p/n 506758) on the new platform as shown.
4. Lift the vehicle.

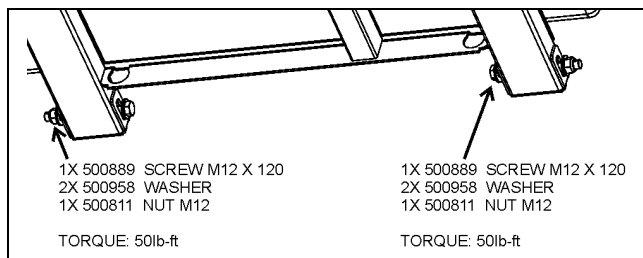
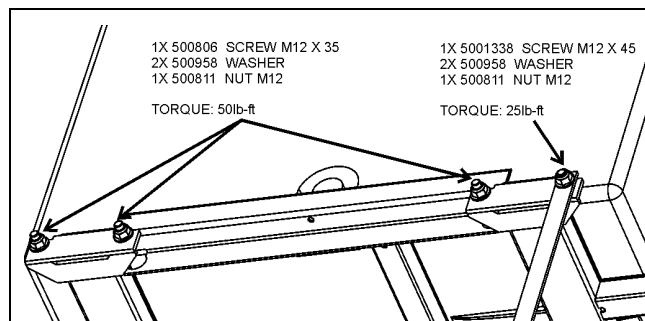
On vehicles affected by this recall, it is **absolutely necessary** to replace the fuel tank support as soon as possible. It has determined that some weakness may exist in the weld beads due to poor fusion penetration. Welding defects are not visible, thus cannot be detected by a visual inspection. No repair is allowed, so the entire support must be replaced.

7. Unscrew the bolts (6) holding the fuel tank support to the vehicle chassis.
8. Replace the existing fuel tank support with the new one. Identify the defective support so it will not be reuse.
9. Install the new support with **new** hardware (bolts, washers and nuts).
 - Tighten bolts to 50 lb-ft (5 bolts)
 - Tighten bolts to 25 lb-ft (with static wick)
