FUSE BOX CONNECTIONS • INSPECT AND TORQUE TIGHTEN 9700 (B13R)

Year model : 2009 to 2011 incl.	From chassis 127142 up to 148659 incl.
---------------------------------	--

Safety Recall

SR11-52A

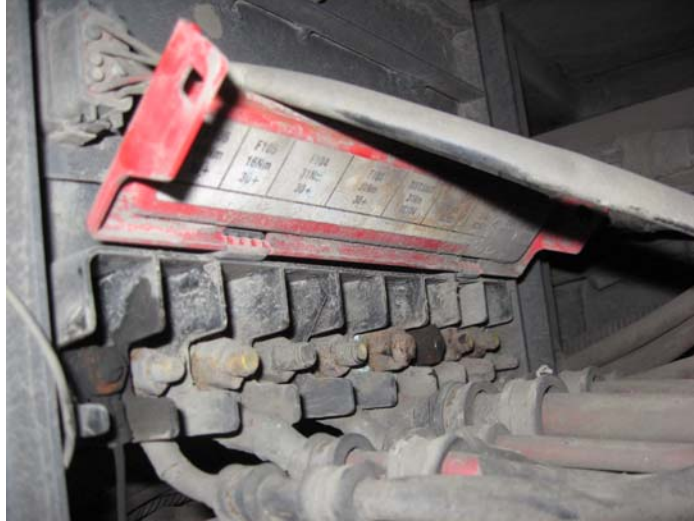
On the vehicles affected by this bulletin, there is a possibility of poorly tightened nuts on the front and rear fuse boxes connections. Symptoms could be poor A/C performance or bad startability. In worst case, this could lead to bad contact, sparks, excessive heat development and melting of terminal sleeves.

2. Check for any damages, inspect and torque tighten all cable connections on front fuse box. See method below. Check also clamping to the bracket of all connected cables and remedy when necessary.

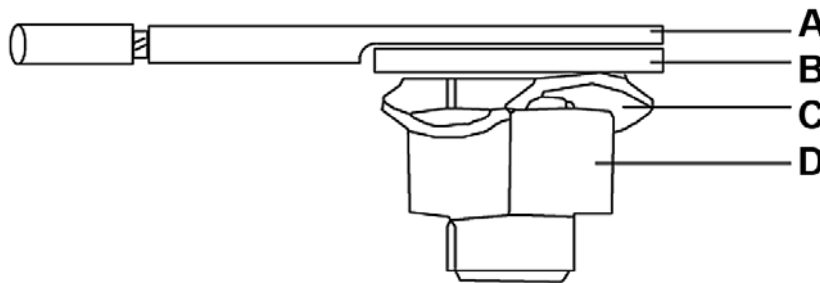
T3021894

- A. Cable terminal
- B. Flat washer
- C. Spring washer
- D. Nut

Check for correct position of washers (B, C) and torque tighten all cable terminals. Make sure the specified tightening torques are obtained.
