PREVOST

SAFETY RECALL

Sr12-24

DATE : JULY 2012	SECTION : 06-ELECTRICAL
SUBJECT : PROPER RUBBING PROTECTION FOR THE JUMP-STARTING POSITIVE TERMINAL BLOCK CABLE

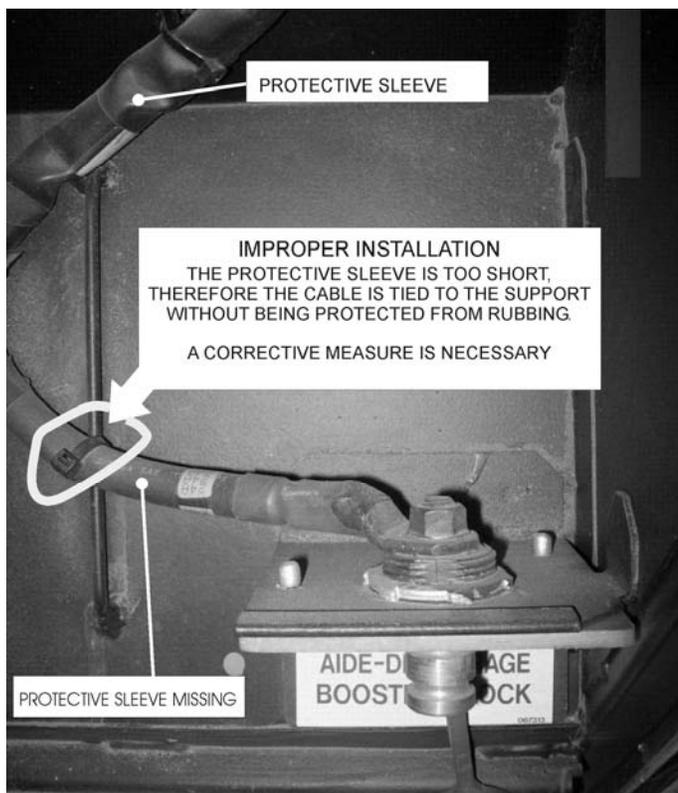
On the vehicles affected by this recall, it is necessary to inspect the jump-start terminal block cable. It is very important that the cable be covered with a protective sleeve to protect from rubbing, especially where it is secured with a nylon tie. Refer to the following procedure to validate correctness of the installation.

1. Open the door giving access to the R.H. side of the engine and locate the positive (red) jump-start terminal block.
2. Check that the protective sleeve covers the cable up to about 2 inches from the terminal. It is very important for the cable to be protected from rubbing at the point where it is secured with the nylon tie (see figure below).
3. If the jump-start positive terminal block cable is not properly protected, order a section of 12 inches long of tubing #562218.
4. When proceeding with the installation of the protective sleeve, it is not necessary to disconnect the cable. Simply slit the sleeve using scissors and place it around the cable.
5. Make sure that the cable is properly covered and protected against rubbing with the protective sleeve at the point of attachment.
6. Finally, secure the cable using a nylon ties.
