PREVOST

**SAFETY
RECALL**

SR13-08A

DATE : MARCH 2013	SECTION : 14-STEERING
SUBJECT : DRAGLINK TURNBUCKLE INSPECTION AND REPLACEMENT

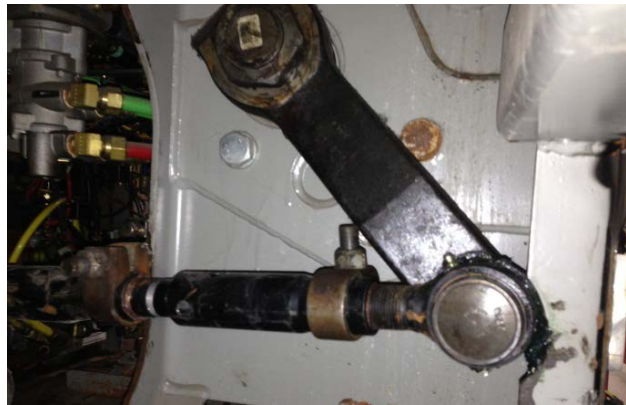
Turn wheels all the way left.

No contact should occur between pitman arm and bolt.

If contact occurs, replace both clamps and turnbuckle. Refer to replacement procedure below.

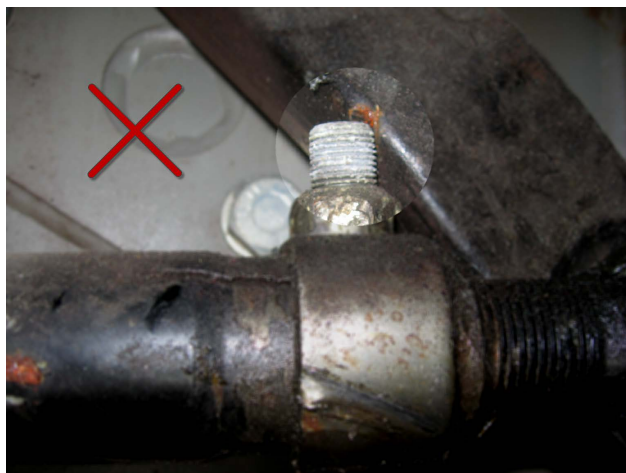
If no contact occurs in the above inspection, visually inspect the fore clamp bolt shank and pitman arm surface for previous contact marks.

Typical signs of contact may be a circular rust spot (1) on the pitman arm and/or flattened threads on bolt shank end (2).

If any one of these contact marks are visible, replace clamps and turnbuckle.

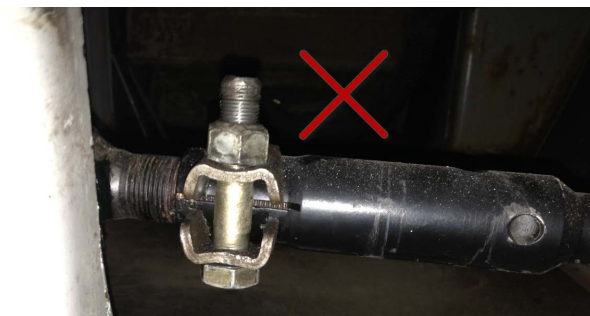
Clamp is bent. Replace clamp.

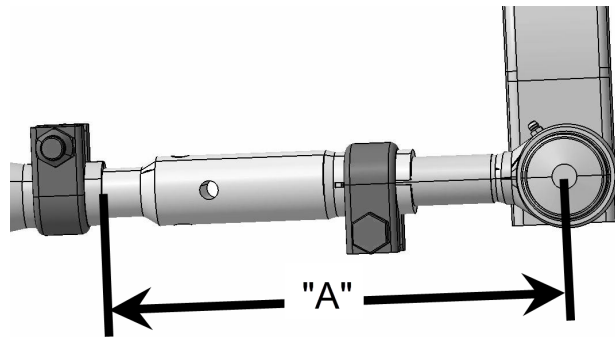
THREADS MUST BE VISIBLE
THE ENTIRE LENGTH OF THE SLOT

At this point, make sure threads are visible the entire length of the slots on the draglink and turnbuckle female ends.
