PREVOST

**SAFETY
RECALL**

SR13-61

DATE :	NOVEMBER 2013	SECTION :	13 – Wheels & Tires
SUBJECT :	DOT Certification Plate for M455 Wide Base Single Tires

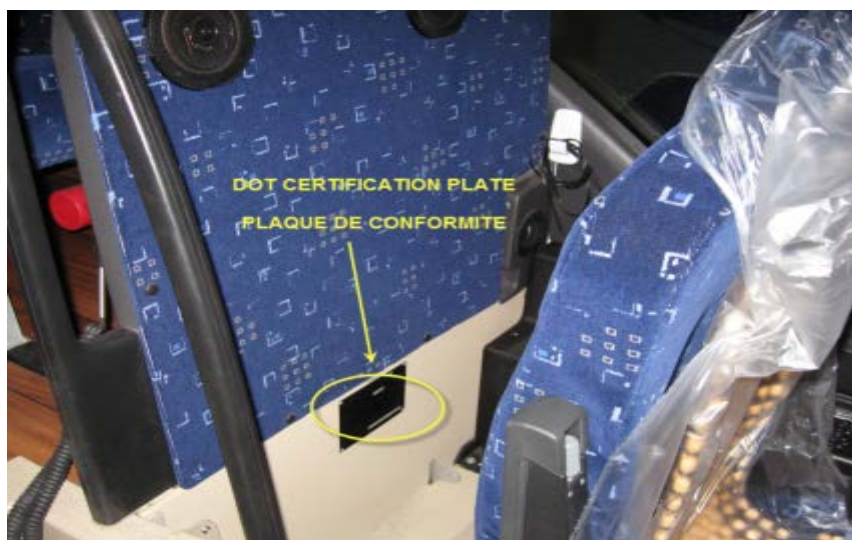
1. Locate the DOT plate installed in one of the following locations:
 - Driver seat back panel on H series vehicles (Fig.1).
 - At knee level on the left lateral control panel, X series vehicles (Fig.2).

Fig.1 DOT Certification Plate, H series vehicles

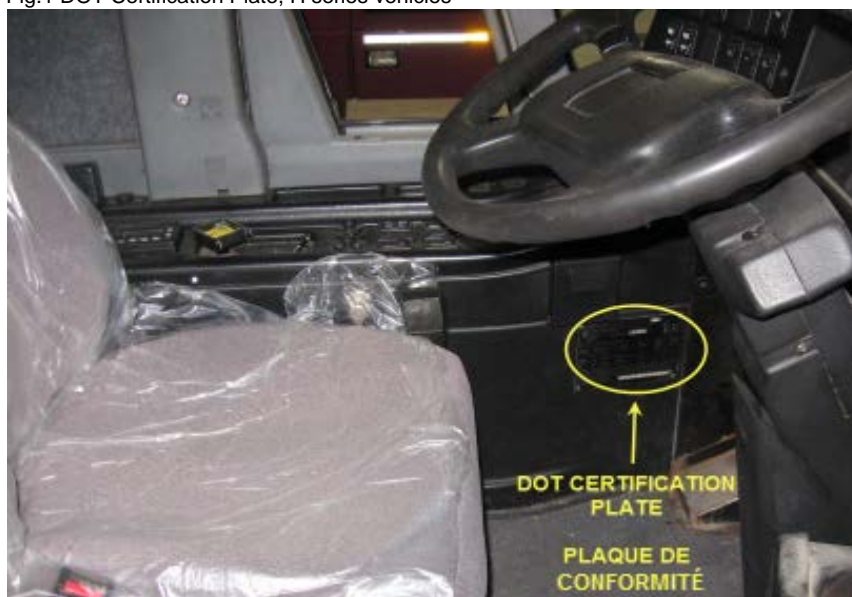
Fig.2 DOT Certification Plate, X series vehicles

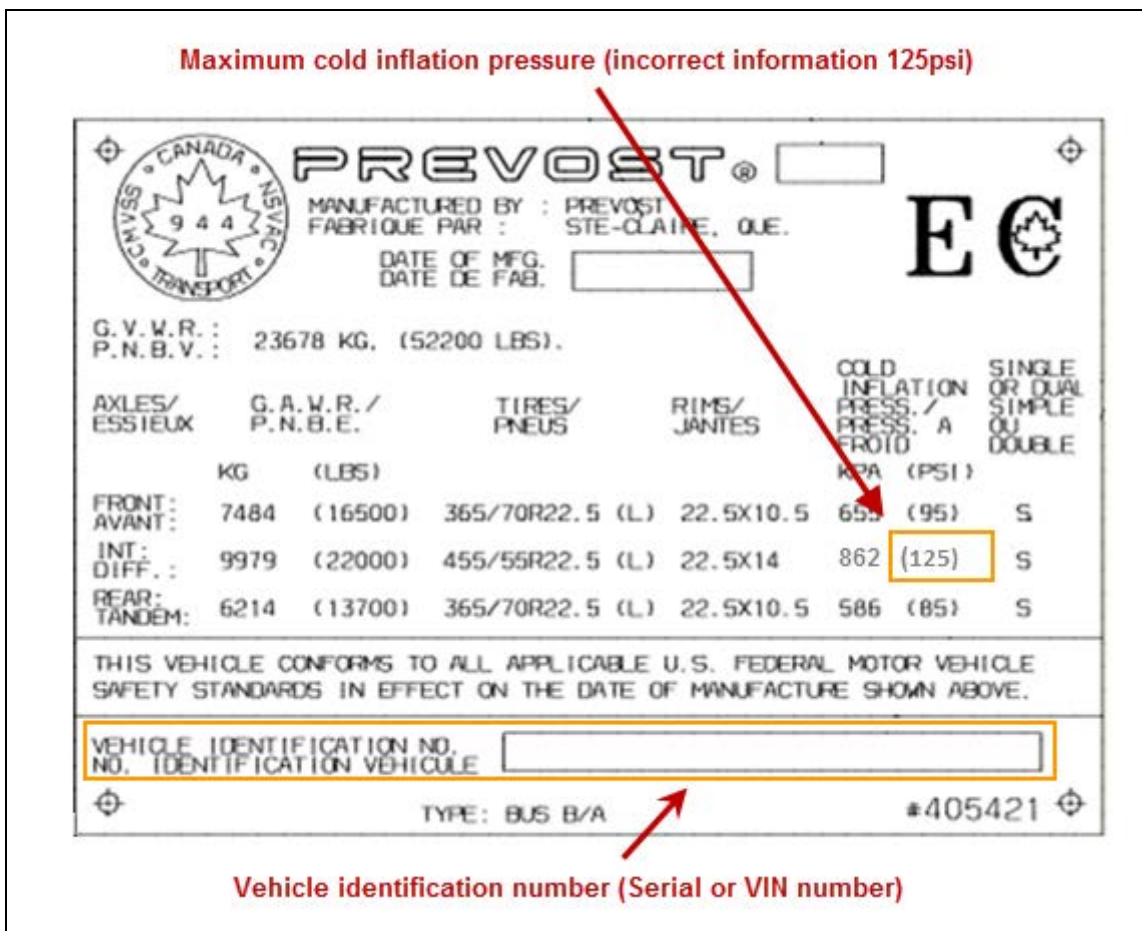
Specifically, the plate displays a maximum of 125psi (862kPa) instead of the 120psi (827kPa) specified by the manufacturer.

2. On the DOT Certification plate, locate the following information (Fig.3).
 - Incorrect maximum inflation pressure on the drive axle (validation).
 - Vehicle identification number (VIN).

Fig.3 Typical DOT certification plate

3. Contact your nearest PrevoSt Service Center to proceed to the plate replacement (specify recall SR13-61). Each plate is individually serialized, the Service Center will need the complete vehicle identification number (VIN) to order the correct replacement plate (Fig.3). Allow 3 to 5 business days for delivery of the new plates.
4. On the vehicle drive axle, verify that the original equipment Michelin X One XDN2 “Super Single” tires are not inflated beyond the 120 cold psi recommended by the manufacturer (Fig.4 and 5 below).
5. Lower the tire pressure as required.

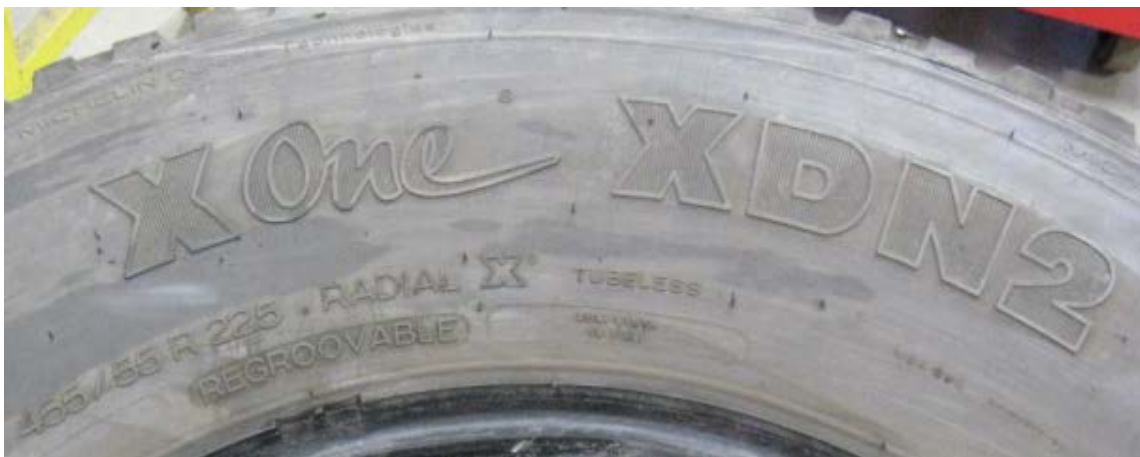
Fig.4 OEM Michelin "X One Super Single" wide base tire (455/55 R22.5).

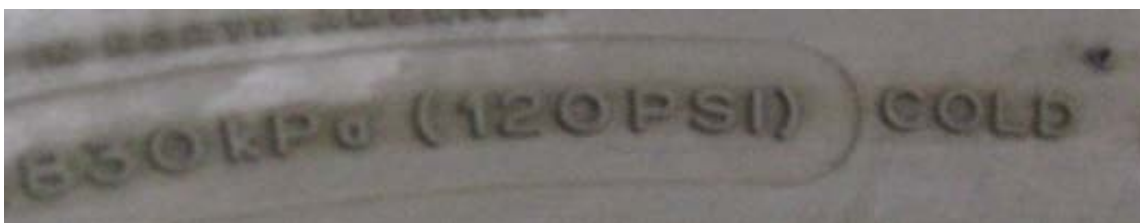
Fig.5 Recommended maximum cold inflation pressure on the tire sidewall.

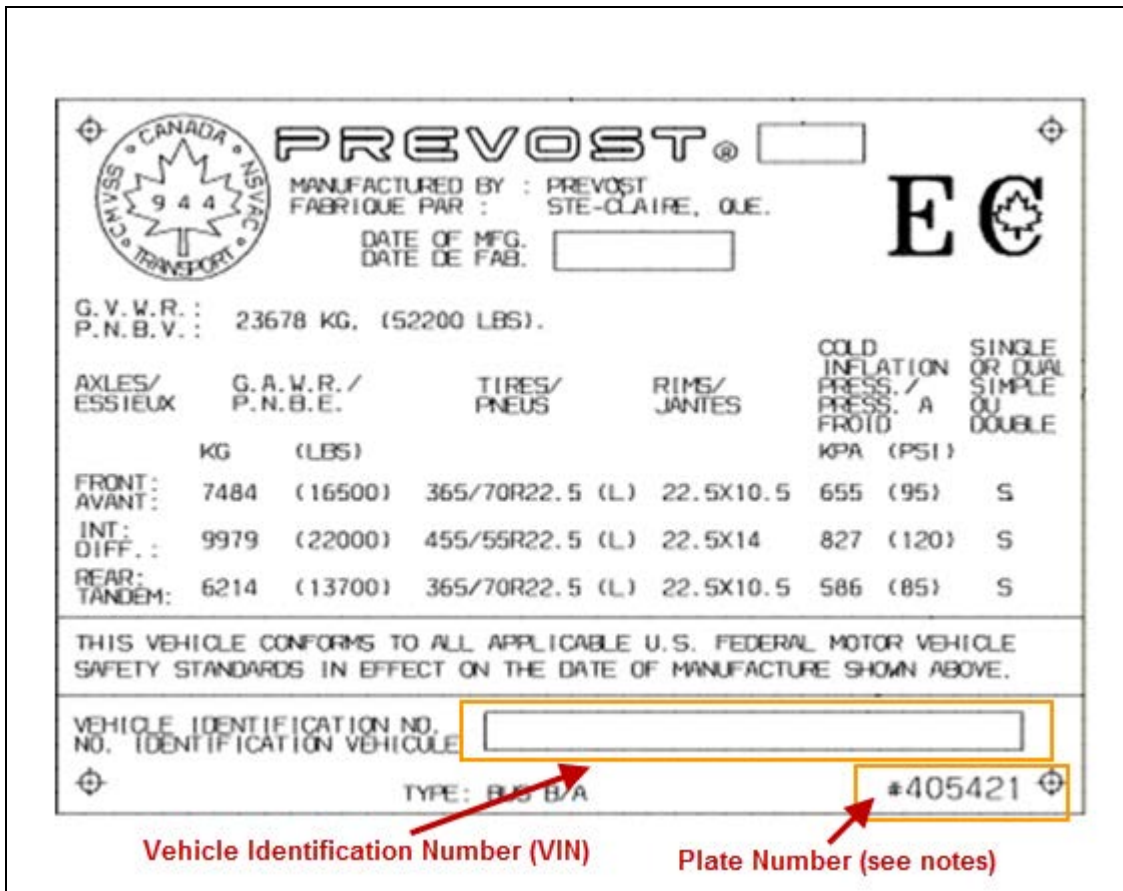
Fig.6 Vehicle Identification Number and Plate number

1. Order a *DOT certification plate* at the Prevost Part Center using the vehicle identification number (VIN).
2. Upon receipt of the new plate, validate the information below :
 - The vehicle identification number on the plate matches the vehicle number.
 - The plate type number (lower right corner) Fig.6 matches the old plate number (see below for exceptions).

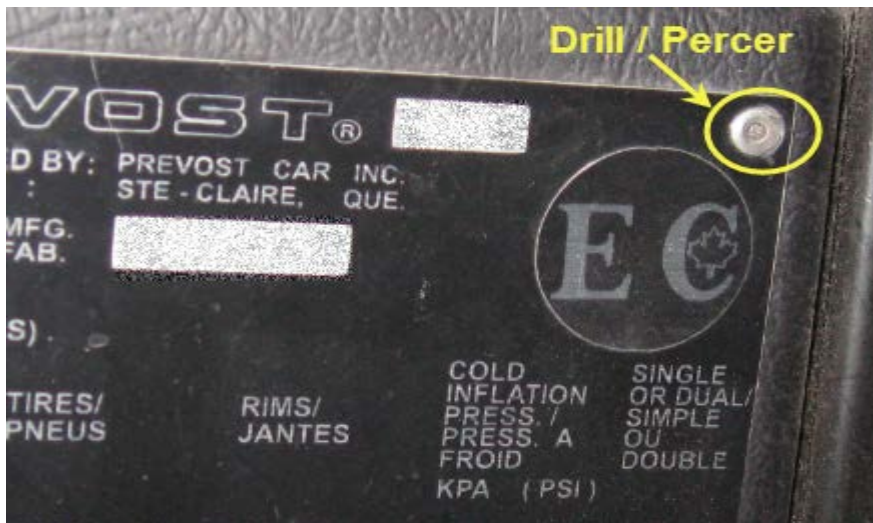
Fig.7 Rivets to be removed (4X).

- The plates are fixed using rivets at each four corners (Fig.7). To remove them, drill the rivet with a drill bit slightly larger than the rivet body to remove the rivet head.

- Remove the plate and push-out the rivets from the mounting holes with a small punch.
- Install the new plate using four (4) new 1/8" diam. rivets.
