**SAFETY
RECALL**

SR13-73

DATE :	DECEMBER-2013	SECTION :	06 - Electrical
SUBJECT:	P-Clamp on Bosch T1 alternators

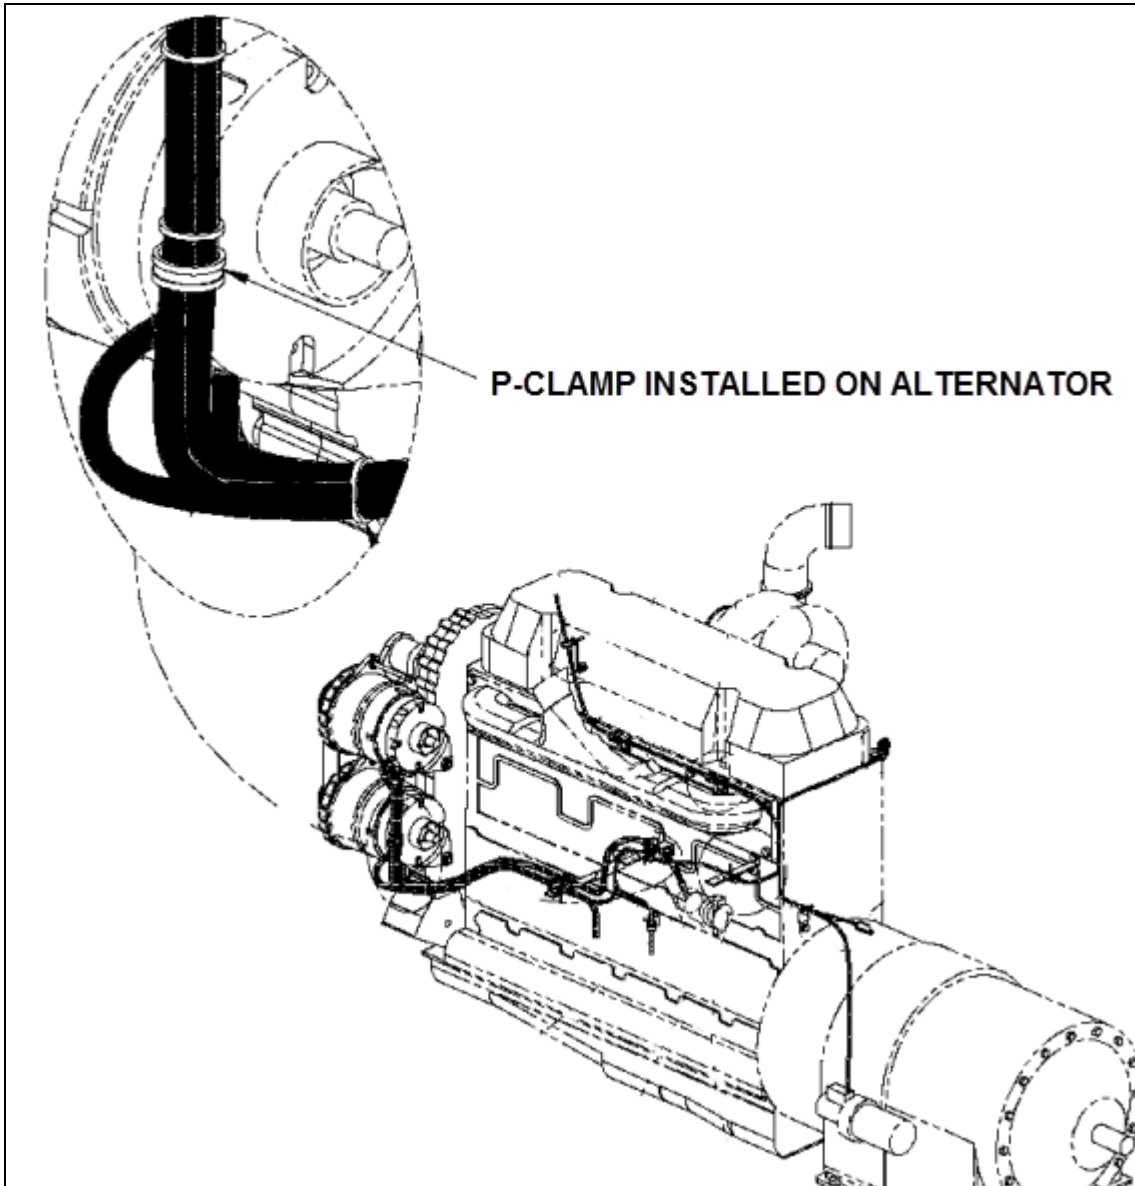
On vehicles affected by this recall, a P-Clamp may have been installed at the back of the lower alternator to hold one of the two (2) power cables coming from the upper alternator.

Since these cables run in close proximity of each other and that only one of the cables runs through the clamp, the other cable may rub against the P-Clamp which over time may result in abrasion of the cable insulation and cause a short circuit.

Fig.3 Details of the P-Clamp installation on the lower BOSCH T1 alternator

3. Unscrew and discard *all* P-clamps found on the alternator bodies (If none were found, make sure all cables are secured as per step 4 below).
4. Using nylon cable ties, secure the cables(s) removed from the P-clamp (and all loose wires) to the vehicle power harness.

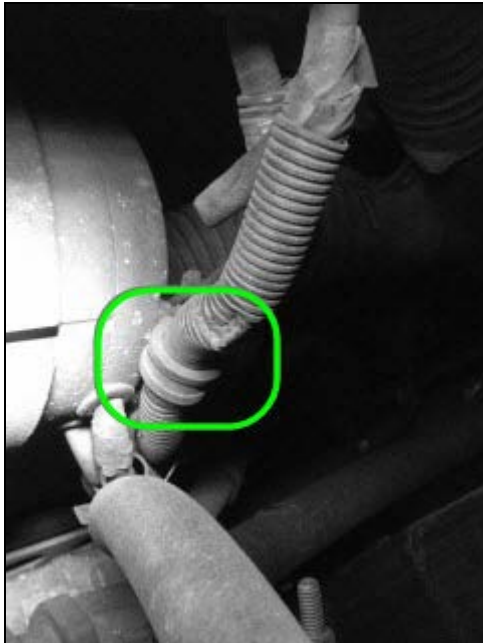
Fig.4 P-clamp on alternator (typical)

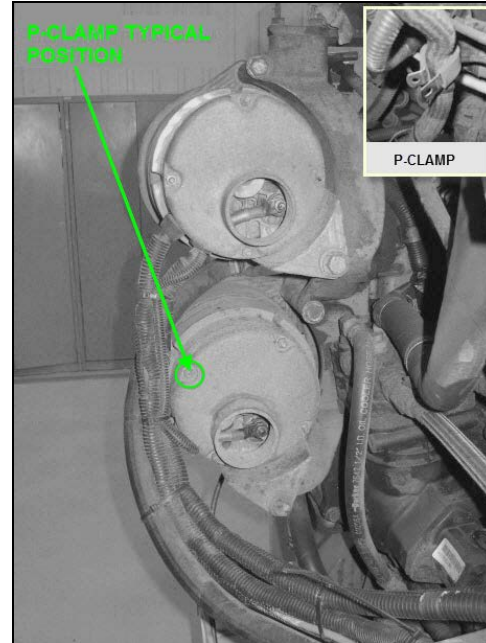
NOTE: In the majority of the vehicles affected by the problem, the P-clamp will be positioned on the top left corner (viewed from the back of the alternators) of the lower alternator (Fig.3 and 5) Nevertheless, inspect both alternators.

Fig.5 P-clamp usual position

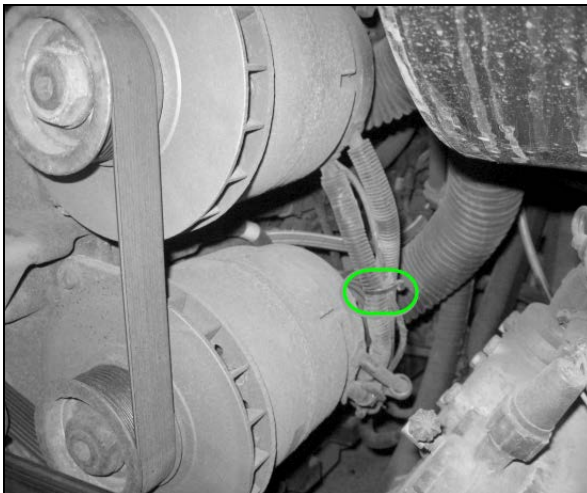
Fig.6 Upper alternator cables secured together

NOTE: Secure as much as possible *all cables* coming from the alternators to the main harness as shown on fig.6 and 7 below.

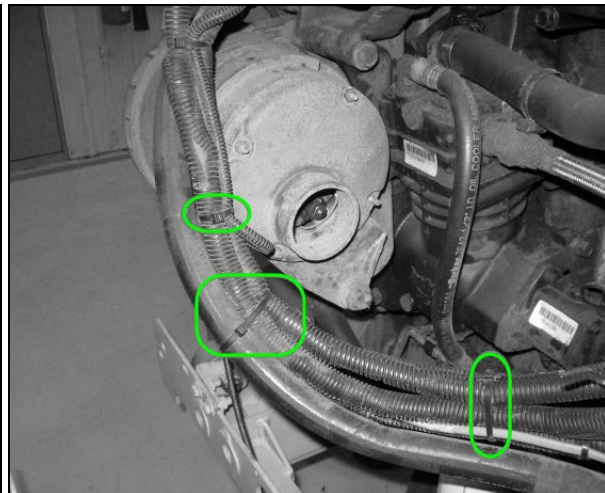
Fig.7 Upper and lower alternator cables going to starter

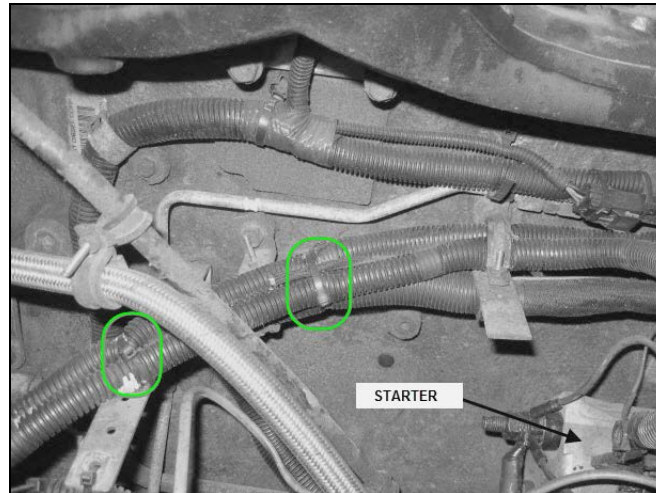
Fig.8 Power cables going to the starter motor

5. Make sure that the cables are correctly secured all the way to the starter unit. Ad cable ties as necessary (Fig.8)
