PREVOST

Warranty Bulletin

96-15

Subject: STARTER CABLES

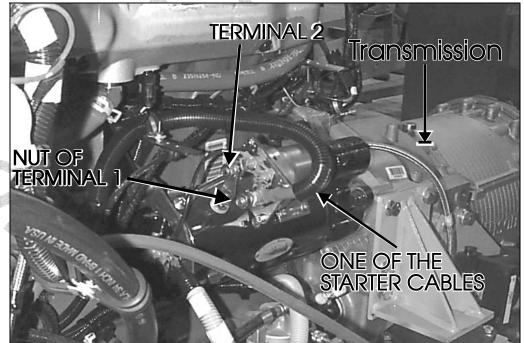
FIGURE 1: STARTER AND TRANSMISSION VUE

On the above-mentioned vehicles, starter cables installation could be wrong and therefore produce a short circuit. This bulletin is divided in three parts: inspection of cables, cable position changes and cables replacement. **This bulletin is a recall campaign because of the fire risk.**

First of all, it is very important to inspect starter cables. Figure 1 shows the proper position of the alternator cable. If your cable position is the same as it is shown on figure 1, this bulletin is finished. If your cable position is different, look at the table listed below. This table shows all the possible observations of starter cables and the corresponding part to performed.

4. Place correctly alternator cable on terminal 1(positive) as shown on figure 1. The cables must form a loop to avoid contact with terminal 2 (negative) of starter's solenoid.

Warning: Figure 1 shows proper position of the alternator cable to terminal 1. Another cable is attached to terminal 1 (positive)(not shown on figure 1). This is the battery cable. These cables must not touch terminal 2 (negative).

- 2. Unscrew starter nut on terminal 1(positive) and remove alternator and battery cables (Fig. 1).
- Insert shrinkable tubing (Prévost #561755) to envelop damage end of alternator cable. This shrinkable tubing should be heated to correctly fit the end of the cable.

Tighten starter nut to 20-25 lbf•ft (27-34 N•m) and make sure that cables keep same position. Secure new alternator cable using old clamps and new tie-raps (Prévost # 504637).

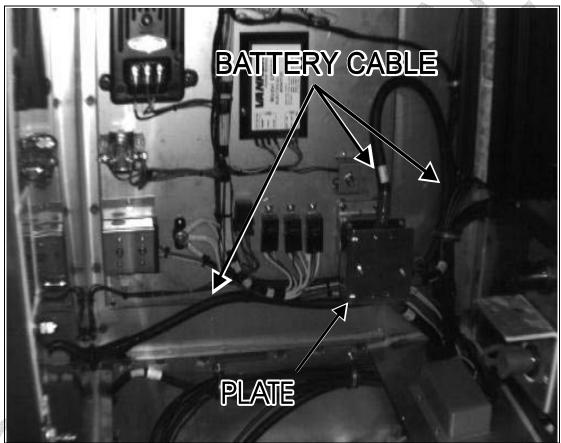
FIGURE 2: MAIN POWER COMPARTMENT

2. Remove damaged starter cables, on terminal 1 (positive). To remove completely battery cable, follow it from starter to the opposite end. For example, on H3 vehicles, opposite end of battery cable is located in main power compartment (Fig. 2) under a plate. To remove the cable, unscrew the two retaining screws and the nut on plate.

- 4. Fix first end of new alternator cable (Prévost #063297) on alternator with a tightening torque of 32 lbf•pi (43 N•m).
- 5. Fix on plate(Figure 2, H3 vehicles), the opposite end of battery cable (not starter's end and for proper number check in the above table). If applicable, reinstall plate with retaining screws.
