PREVOST

Warranty Bulletin

96-18

Date: **October 1996**
Section: **06**
Subject: **BOOSTER POST POWER CABLE INSPECTION**
Application:

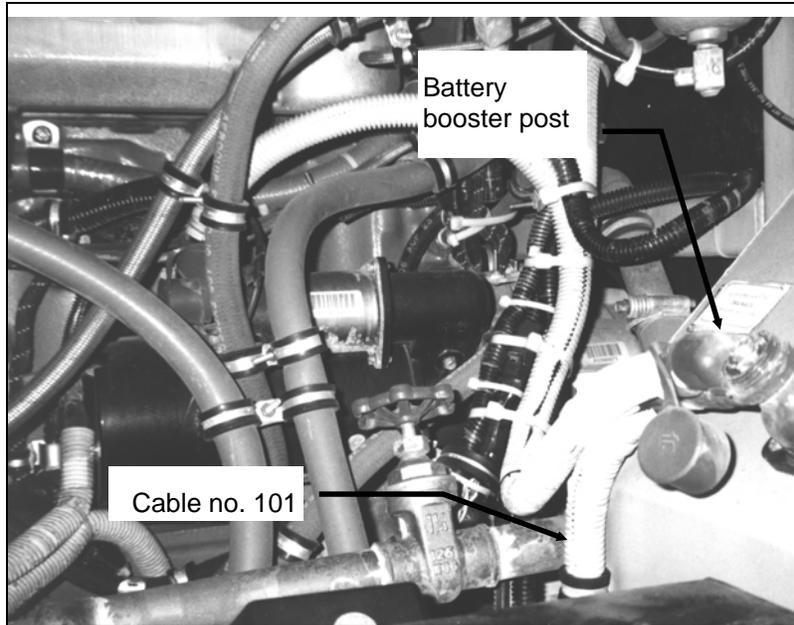
FIGURE 1: CABLE LOCATION

On the above-mentioned vehicles, the main power cable which brings power from the cut-out switch to the battery booster post in the engine bay could use prematurely due to friction. Friction of this cable on the vehicle structure or any mechanical components could cause a fire in the engine compartment. It is paramount that your vehicle be inspected and corrective actions be taken, if required, to properly secure the cable as explained herein. There are three sections (or tasks) in this bulletin. Depending on the condition of the cable on your vehicle, you are requested to complete section A (mandatory), and possibly section B or C (depending on cable condition). **Note that this is a SAFETY RECALL CAMPAIGN.**

1. In the engine compartment, locate cable 101A (Fig. 1).
2. Inspect cable for any damages caused by friction on sharp or abrasive objects. Pay particular attention to the section of the cable which is routed close to the engine cradle leg. Figure 2 shows the particularly sharp edges of the cradle leg where abrasion could occur.

3. If cable is slightly damaged (i.e. insulation of cable slightly cut and/or ground) go directly to **Section B**.
4. If cable is no longer useable (i.e. copper inside cable is cut and/or burnt) go directly to **Section C**.
5. Move cable with your hand and make sure that:
 - a. cable does not rub on any sharp or abrasive objects.
 - b. cable does not get closer than 2" (5 cm) to any sharp or abrasive objects.

-
- If cable rubs on a sharp or abrasive object or if it gets within 2" (5 cm) of one, secure cable with cable ties (Prevost #504016) to prevent premature damage to cable.
