PREVOST

**SAFETY
RECALL**

Sr97-25

DATE: December 1997	SECTION: 16
SUBJECT: ADDING REINFORCEMENTS TO THE DIFFERENTIAL CROSS-MEMBER

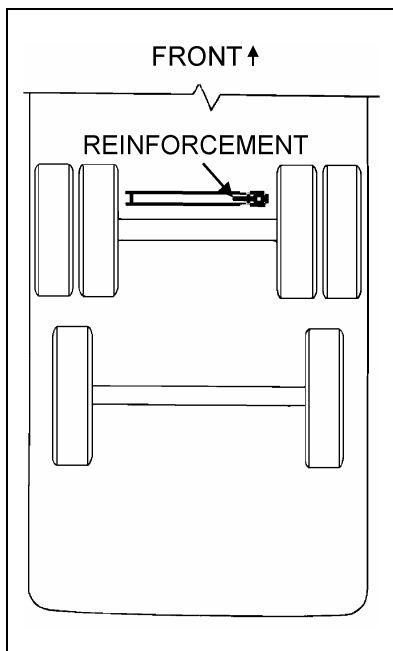
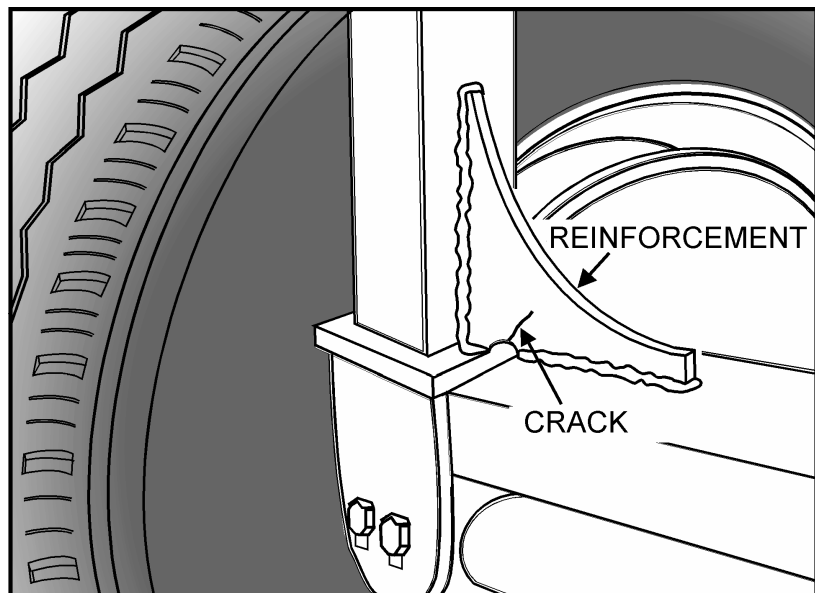
On the above-mentioned vehicles, the design of differential cross-member reinforcement has been found inadequate under certain rough applications. The installation of two other reinforcements will solidify the assembly and avoid that a crack occurs on reinforcement already in place. The probability that a crack occurs is more important on vehicles on which the radius rod bolting procedure has not been observed thus increasing the stress on differential cross-member reinforcement. Consequently, we ask you to install two reinforcements **and** perform the verification steps described in the following procedure.

1. Working underneath vehicle in the area located at center in front of differential, carefully check if there is a crack on the differential cross-member reinforcement (refer to figures 1 and 2). In such a case, grind cracked area to bare metal then fill crack with welding.

Adjust the welding machine according to the following parameters:

- * FCAW (Flux cored-Arc Welding) process;
- * welding rod conforms to CSA W48.5 - M1990 specifications
- * E4801 - T9CH type welding rod with 0.045" diameter (1,2 mm)
- * voltage: 24 @ 28 volts
- * current: 325 @ 375 amperes
- * wire feed rate: 280 ipm
- * shielding gas: 75% argon and 25% CO²

2. Allow welding to cool, remove slag then paint the exposed areas with a rust preventive product.

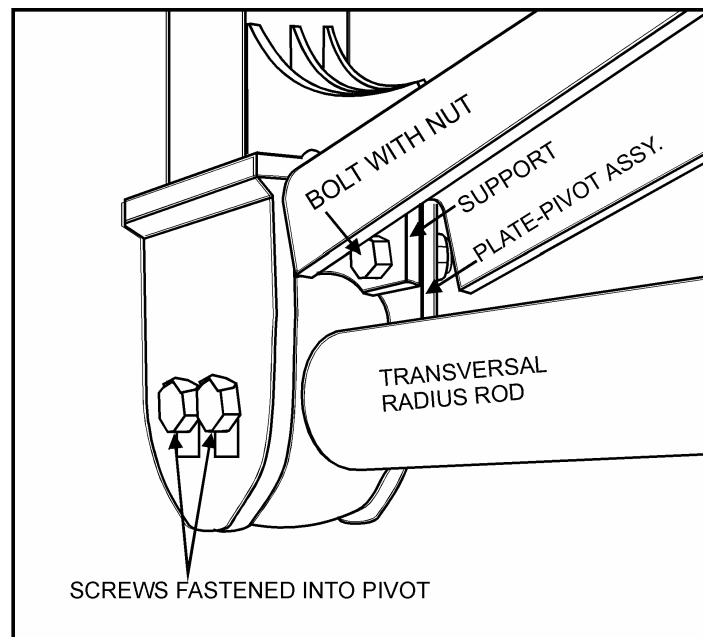
FIGURE 7

2. Using a torque wrench, check if tightening torque for each of the two bolts (with nuts) is superior to 120 lbf?ft and furthermore check if a displacement of transversal radius rod plate-pivot assembly in relation to its support occurred which would indicate that an undesirable substance (grease, rust preventive product etc.) have been left on one of these parts during assembly.

1. Identify just below the reinforcements previously welded, the two bolts (with nuts) fastening the plate-pivot assembly of transversal radius rod to its support (refer to figure 7).

- In the case where the tightening torque is inferior to 120 lbf?ft **and** no displacement occurred, then go to step 3.
- In the case where a displacement occurred no matter the tightening torque, go to step 3 but in addition, replace the transversal radius rod plate-pivot assembly with a new one (#131420). Keep plate-pivot assembly for reimbursement.
- In the case where the tightening torque is superior to 120 lbf?ft **and** no displacement occurred, then remove and discard the two screws directly fastened into radius rod pivot (also discard the locking tab plate), tap both threaded holes (M16 x 2) of radius rod pivot. Coat both new screws (#502544) with white grease, position a new locking tab plate (#110340) then alternately tighten up to 120 lbf?ft. Fold locking tab over screw heads. Go to the verification of assembly #2 page 6.

3. Dismount the radius rod by unscrewing from one side the two bolts (with nuts) and from the other by flattening the tabs of locking plate and by unscrewing the two screws directly fastened into radius rod pivot (if needed, refer to maintenance manual). Discard screws, bolts, nuts and locking tab plate. Thoroughly clean the contact surfaces between the plate-pivot assembly and its support by removing all trace of grease or rust preventive product. Tap both threaded holes (M16 x 2) of radius rod pivot.

4. Use new bolts (#502544), nuts (#500781) and locking tab plate (#110340). Coat new bolts (and screws) with white grease, position radius rod then manually tighten bolts and screws.

5. Alternately tighten bolts and screws up to 120 lbf?ft. Fold locking tab over screw heads.

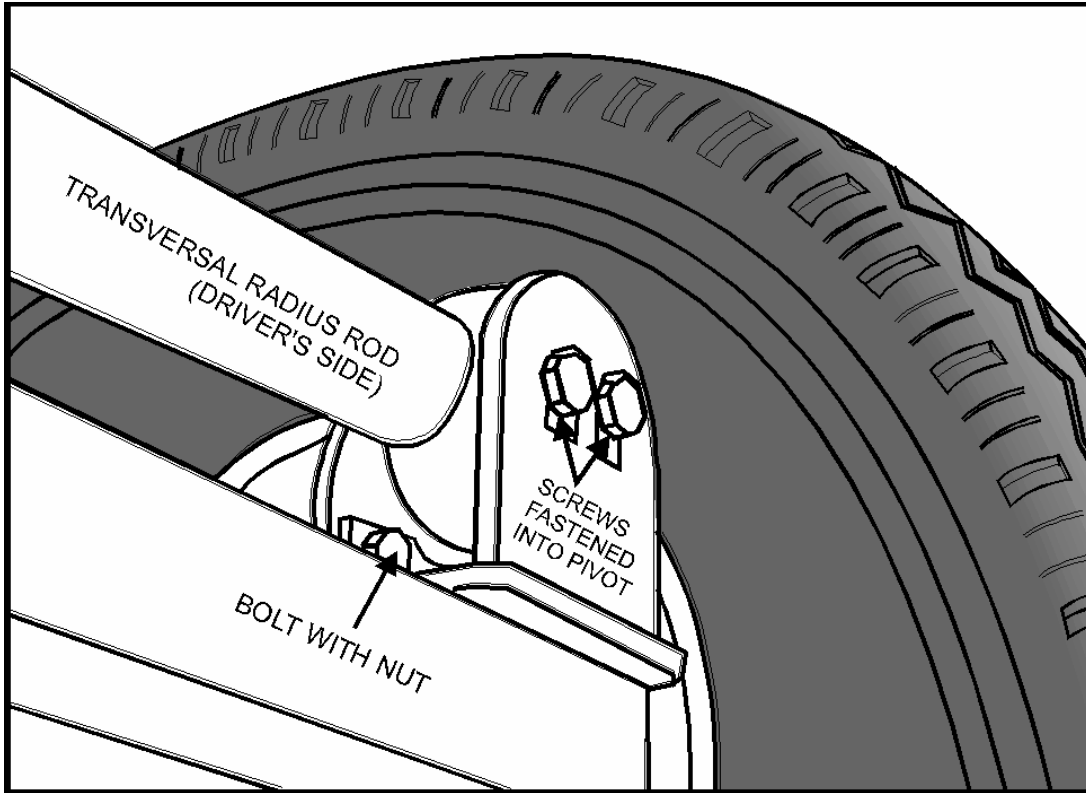
FIGURE 8 - VIEW FROM FRONT

2. Using a torque wrench, check if tightening torque for each of the two bolts (with nuts) is superior to 120 lbf?ft and furthermore check if a displacement of transversal radius rod plate-pivot assembly in relation to its support occurred which would indicate that an undesirable substance (grease, rust preventive product etc.) have been left on one of these parts during assembly.

1. Identify on a similar type of assembly but this time located at the other extremity of transversal radius rod (driver's side), the two bolts (with nuts) fastening the plate-pivot assembly of transversal radius rod to its support (refer to figure 8).

- In the case where the tightening torque is inferior to 120 lbf?ft **and** no displacement occurred, then go to step 3.
- In the case where a displacement occurred no matter the tightening torque, go to step 3 but in addition, replace the transversal radius rod plate-pivot assembly with a new one (#131420). Keep plate-pivot assembly for reimbursement.
- In the case where the tightening torque is superior to 120 lbf?ft **and** no displacement occurred, then remove and discard the two screws directly fastened into radius rod pivot (also discard the locking tab plate), tap both threaded holes (M16 x 2) of radius rod pivot. Coat both new screws (#502544) with

white grease, position a new locking tab plate (#110340) then alternately tighten up to 120 lbf?ft. Fold locking tab over screw heads. Go to the verification of assembly #3 page 8.

3. Dismount the radius rod by unscrewing from one side the two bolts (with nuts) and from the other by flattening the tabs of locking plate and by unscrewing the two screws directly fastened into radius rod pivot (if needed, refer to maintenance manual). Discard screws, bolts, nuts and locking tab plate. Thoroughly clean the contact surfaces between the plate-pivot assembly and its support by removing all trace of grease or rust preventive product. Tap both threaded holes (M16 x 2) of radius rod pivot.

4. Use new bolts (#502544), nuts (#500781) and locking tab plate (#110340). Coat new bolts (and screws) with white grease, position radius rod then manually tighten bolts and screws.

5. Alternately tighten bolts and screws up to 120 lbf?ft. Fold locking tab over screw heads.

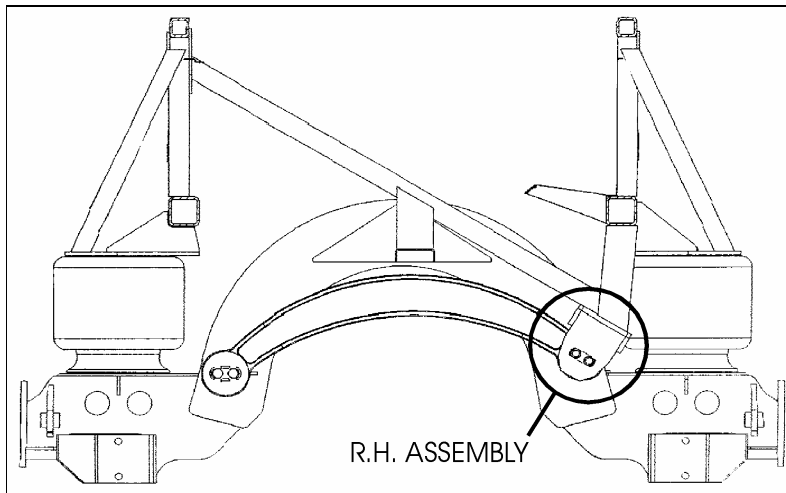
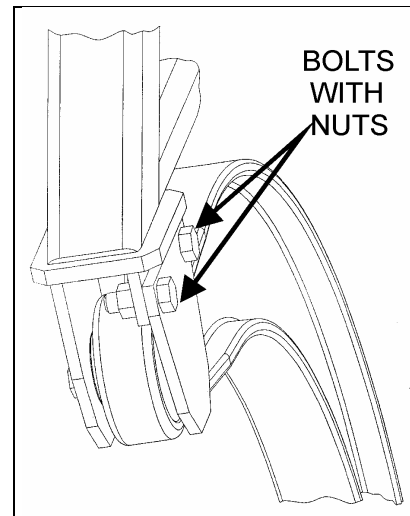
2. Using a torque wrench, check if tightening torque for each of the two bolts (with nuts) is superior to 120 lbf?ft and furthermore check if a displacement of transversal radius rod plate-pivot assembly in

relation to its support occurred which would indicate that an undesirable substance (grease, rust preventive product etc.) have been left on one of these parts during assembly.

1. Identify on R.H. assembly of tag axle transversal radius rod, the two bolts (with nuts) fastening the plate-pivot assembly of transversal radius rod to its support (refer to figures 9 and 10).

- In the case where the tightening torque is inferior to 120 lbf?ft **and** no displacement occurred, then go to step 3.
- In the case where a displacement occurred no matter the tightening torque, go to step 3 but in addition, replace the transversal radius rod plate-pivot assembly with a new one (#131420). Keep plate-pivot assembly for reimbursement.
- In the case where the tightening torque is superior to 120 lbf?ft **and** no displacement occurred, then remove and discard the two screws directly fastened into radius rod pivot (also discard the locking tab plate), tap both threaded holes (M16 x 2) of radius rod pivot. Coat both new screws (#502544) with white grease, position a new locking tab plate (#110340) then alternately tighten up to 120 lbf?ft. Fold locking tab over screw heads, then go to the step concerning the verification of suspension components page 9.

3. Dismount the radius rod by unscrewing from one side the two bolts (with nuts) and from the other by flattening the tabs of locking plate and by unscrewing the two screws directly fastened into radius rod pivot (if needed, refer to maintenance manual). Discard screws, bolts, nuts and locking tab plate. Thoroughly clean the contact surfaces between the plate-pivot assembly and its support by removing all trace of grease or rust preventive product. Tap both threaded holes (M16 x 2) of radius rod pivot.

4. Use new bolts (#502544), nuts (#500781) and locking tab plate (#110340). Coat new bolts (and screws) with white grease, position radius rod then manually tighten bolts and screws.

5. Alternately tighten bolts and screws up to 120 lbf?ft. Fold locking tab over screw heads.
