**WARRANTY
 BULLETIN**

Wb05-03

DATE : MARCH 2005	SECTION : 05 - Cooling
EXPIRATION: MARCH 2007	
SUBJECT: REPLACEMENT OF THE BELT TENSIONER AIR BELLOWS ATTACHMENT BRACKETS

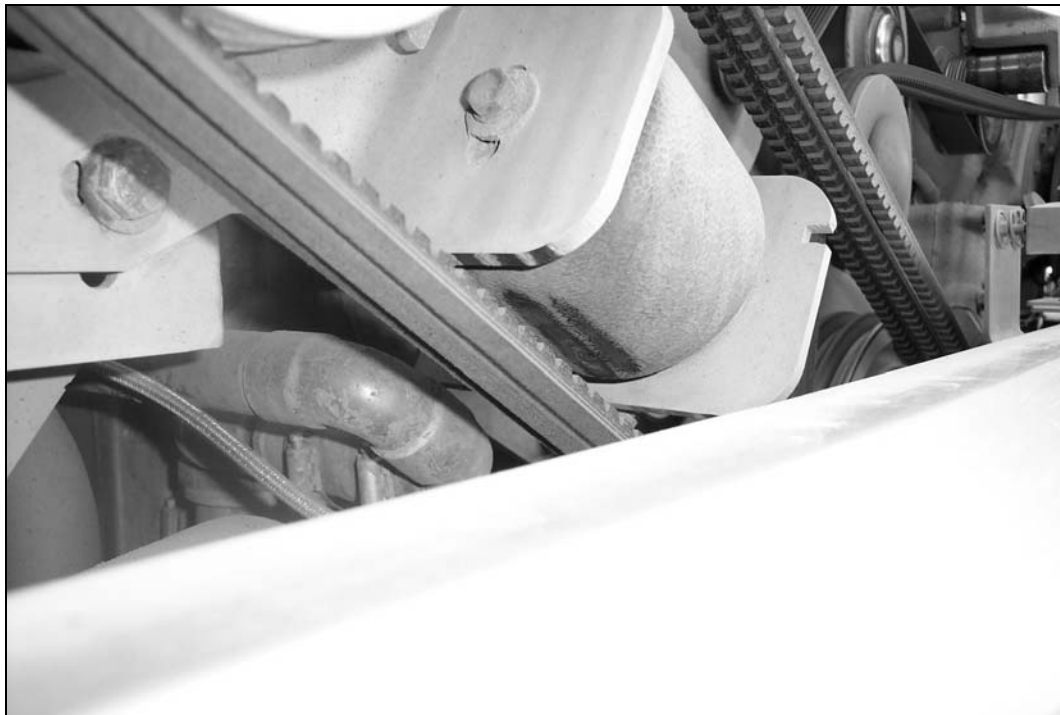
FIGURE 3

On the above-mentioned vehicles, it is necessary to replace the belt tensioner air bellows attachment brackets in order to reduce the risk of rubbing between the air bellows and the belts. It is also necessary to check the air bellows and belts for signs of damage due to rubbing and to replace them if needed.

5. Check if the air bellows (550840) and belts (505522) were damaged as shown in figure 3, replace as needed.
6. Reinstall the air bellows fittings. Use some Teflon tape on the threads.
