**WARRANTY  
 BULLETIN**

Wb07-01

<b>DATE :</b> MAY 2007	<b>SECTION :</b> 16 - Suspension
<b>EXPIRATION:</b> MAY 2009	
<b>SUBJECT :</b> RETAINING RING INSTALLATION ONTO FRONT SUSPENSION SWAY BAR

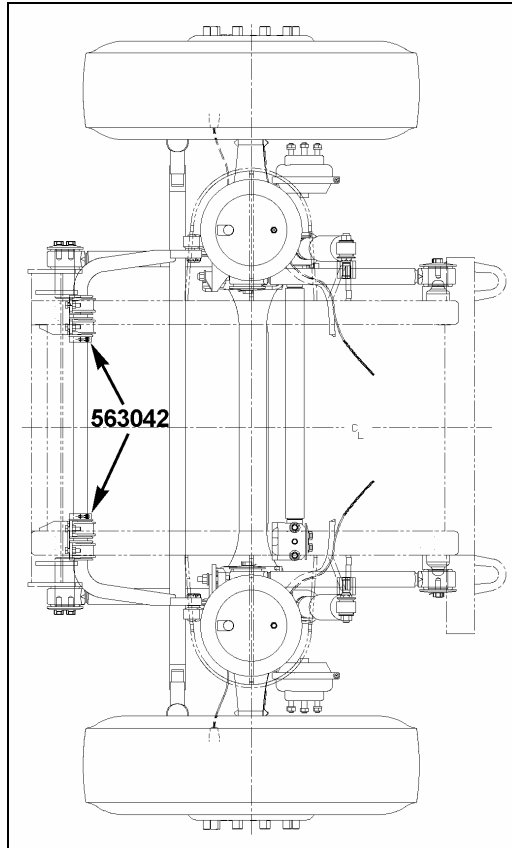
FIGURE 1

On the above-mentioned vehicles, the installation of retaining rings may have been omitted on the sway bar of I-beam axle front suspension equipped vehicles. This situation may create lateral displacement of the sway bar and cause additional stress to the clamp collars. It is necessary to check the presence of retaining rings identified in this bulletin and to install them if necessary.

Check if the retaining rings were installed onto the vehicle front sway bar (Refer to figures 1 and 2).

Two retaining rings are required, one on each clamp collar side towards the center of vehicle

1. Center sway bar with reference to clamp collars.
2. Install retaining rings. Apply some "Loctite" 243 blue onto the retaining ring bolt threads.
