WARRANTY BULLETIN

DATE: AUGUST 2009	SECTION :	18 - BODY
EXPIRATION: AUGUST	2011	
SUBJECT: HEADLIGHTS REPLACEMENT

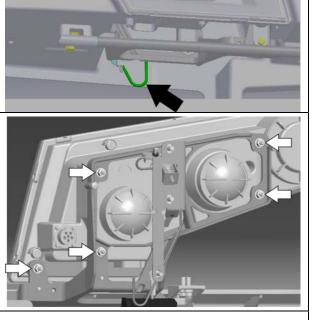
- 4. Remove 5 indicated nuts (white arrows) and disconnect the electrical harness. Do not loosen any other piece of hardware as you could lose the original headlight adjustment.
- 5. Remove the headlight housing.
- 6. Install the new headlight housing. To do so, repeat the previous steps in reverse order.
- 7. The headlight position in relation to the support doesn't need to be readjusted.
- 8. Headlight aiming is adjusted at time of manufacturing and doesn't need to be readjusted. However, should an adjustment be necessary, the vertical aiming is provided by one adjusting screw (indicated by white arrow) that pivots both high and low beams simultaneously.
