PREVOST

**WARRANTY
BULLETIN**

Wb09-23

DATE: JANUARY 2010	SECTION: 23 - Accessories
EXPIRATION: JANUARY 2012	
SUBJECT: PREHEATER EXHAUST PIPE HOLDING CLAMP

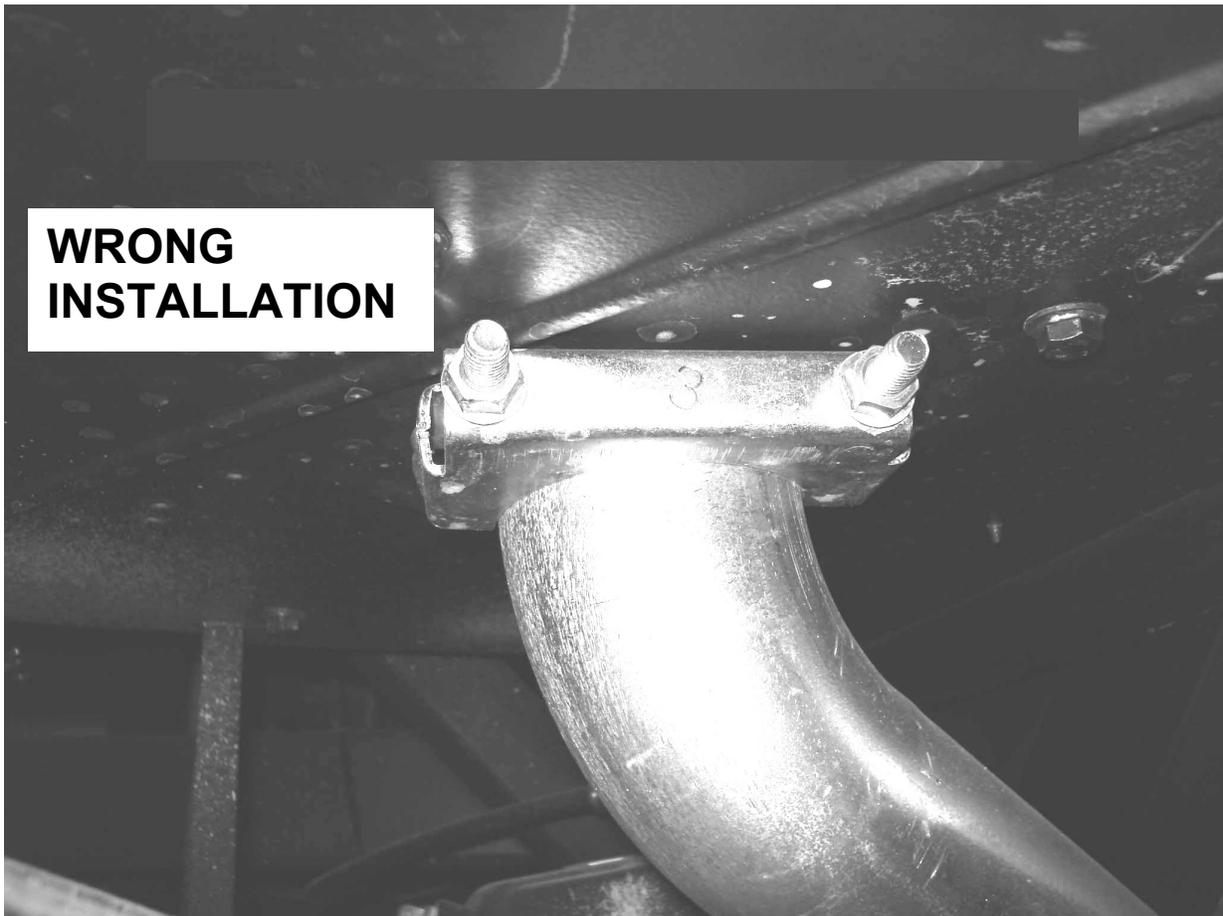
**WRONG
INSTALLATION**

On the vehicles affected by this bulletin and equipped with a preheater, there is a possibility that the clamp holding the preheater exhaust pipe be not properly positioned.

1. Check if the clamp holding the preheater exhaust pipe is located above or beneath the splash guard panel. This splash guard panel is located above the tag axle L.H. side wheel.
2. In the case where the clamp is located under the panel, it must be removed and repositioned.

1. Dismount rear L.H. side fender.
2. Remove the clamp located beneath the splash guard panel and relocate it above the panel.
3. Reinstall rear L.H. side fender.

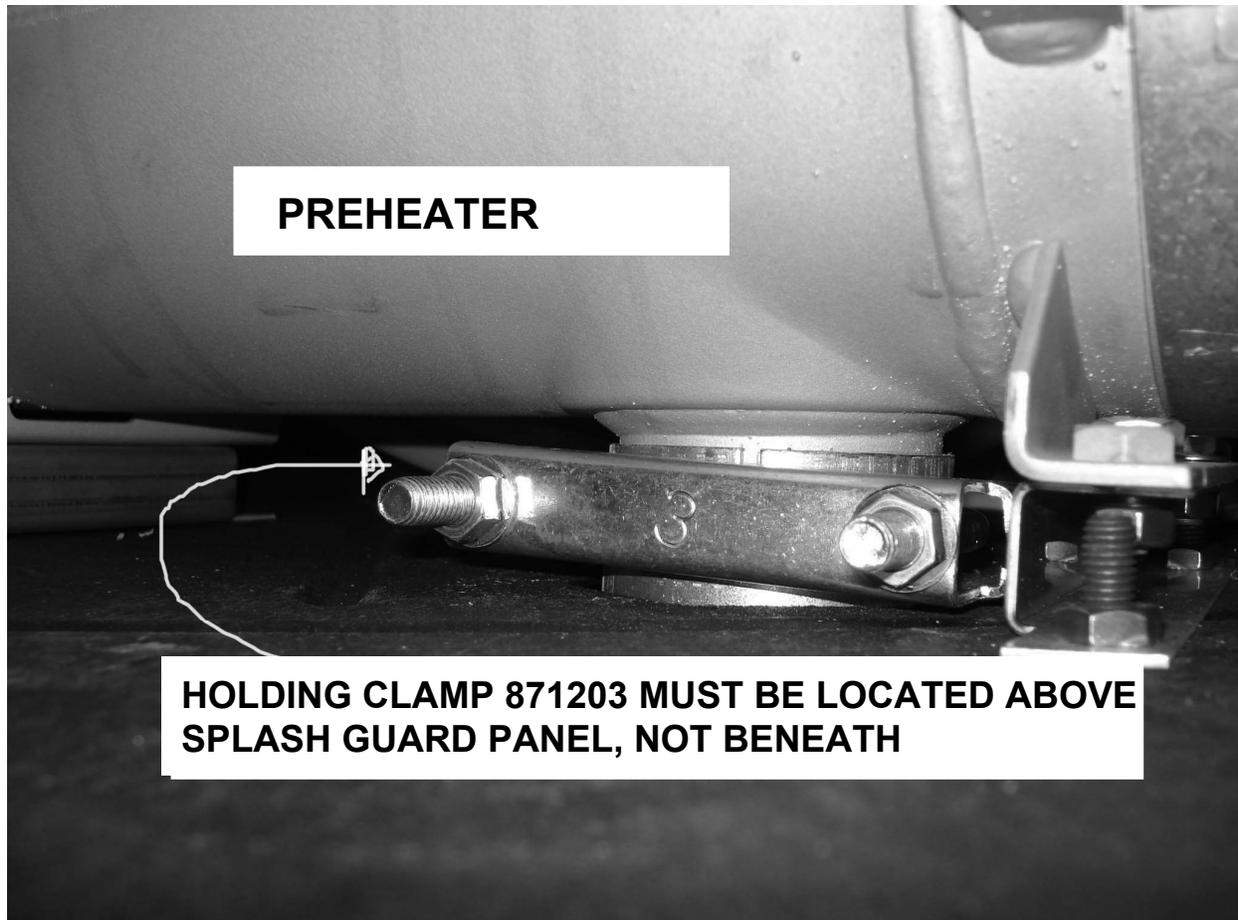
Make sure that holding clamp is located above splash guard panel and not beneath.
