WARRANTY BULLETIN

Wb11-01A

DATE : FEBRUARY 2011	SECTION : 01 - Engine
EXPIRATION: FEBRUARY 2013	
SUBJECT : VOLVO D13 ENGINE AFTERTREATMENT HYDROCARBON INJECTOR (AHI) FUEL LINE FITTINGS – PROPER TIGHTENING VERIFICATION

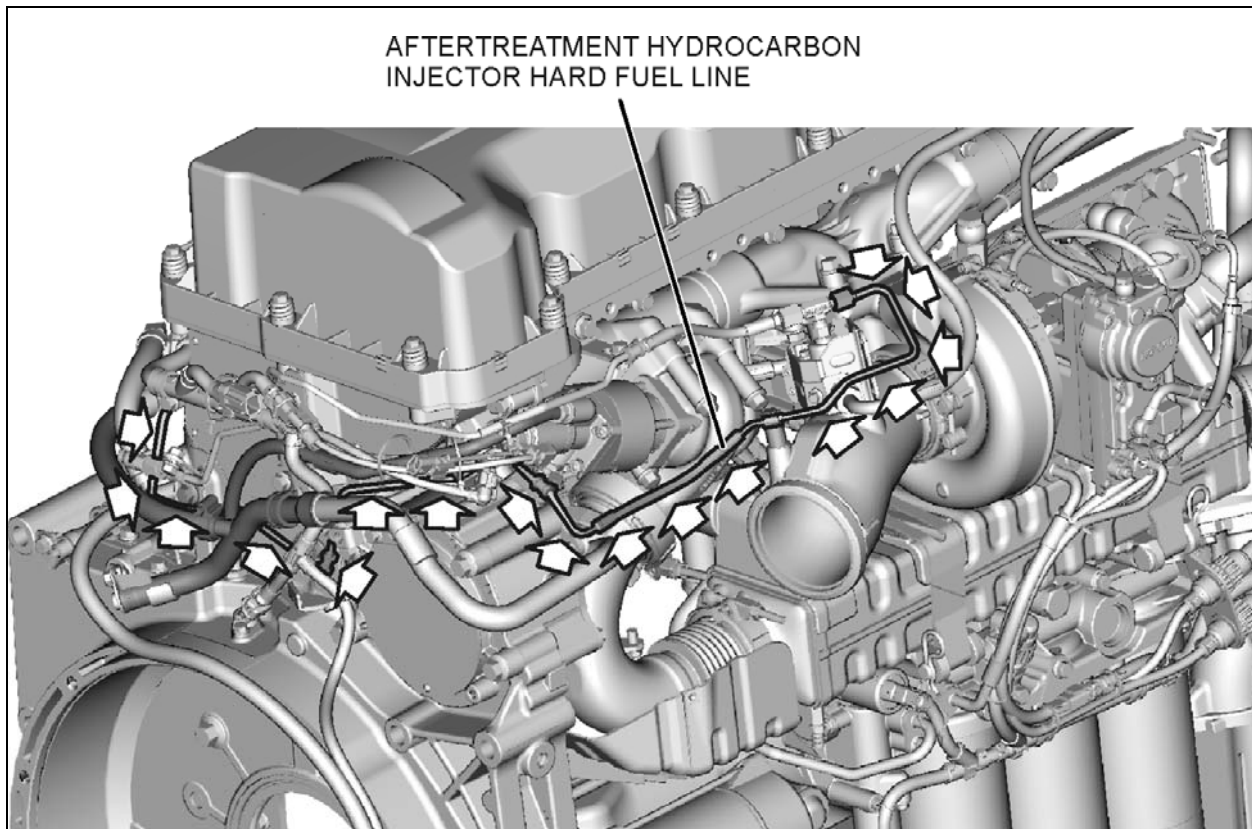
1. Open the engine compartment door and the engine access hatch found at the rear of the passenger's area.
2. Locate the aftertreatment hydrocarbon injector hard fuel line on the engine (see image below).

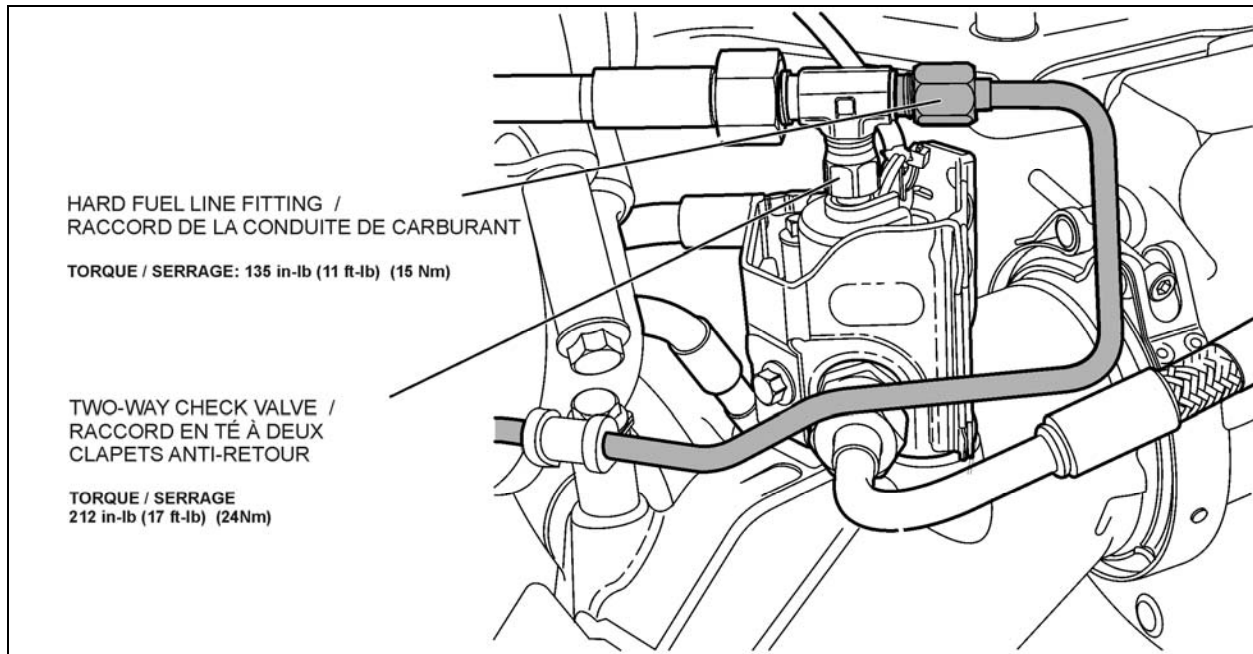
On the vehicles affected by this bulletin, it is necessary to check if the aftertreatment hydrocarbon injector hard fuel line fittings are properly tighten. Loose fittings can leak.

3. Check that the hard fuel line fitting connected to the two-way check valve is properly tighten (see image below). If necessary, tighten fitting to prevent fuel leaks (torque: 135 lb-in, 15 Nm). When tightening the fuel line fitting, secure the two-way check valve with a wrench, do not allow tightening force to be transmitted to the check valve nipple. Damage to nipple can result.
4. While securing the two-way check valve with a wrench, tighten the check valve swivel nut if loose (torque: 212 lb-in, 24 Nm).
