WARRANTY BULLETIN

Wb11-18

SUBJECT: WELDING BEAD VERIFICATION – ENGINE

COMPARTMENT DOOR GAS SPRING SUPPORT

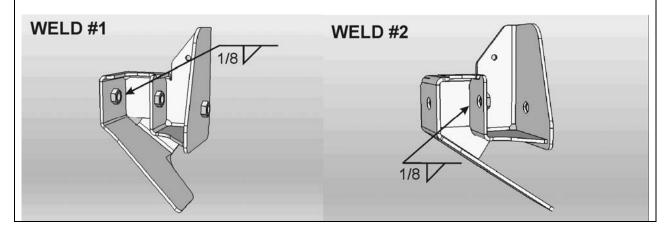
On the vehicles affected by this bulletin, a verification of the engine compartment door gas spring support is necessary. Weld beads might be missing.

4. If weld #1 or #2 is missing, then proceed to the corrective measure of part 2.

- 1. Before undertaking welding on the support, it is absolutely necessary to disconnect the electronic modules as they may be damaged. Refer to procedure «MULTIPLEX MODULES DISCONNECTION PROCEDURE PRIOR TO WELDING PR060041».
- 2. Place the ground clamp as close as possible to the welding area. Add any missing weld bead. Perform a 3mm (1/8") fillet weld.
