# PREVOST

## WARRANTY BULLETIN

WB12-35

DATE : NOVEMBER 2012	SECTION :	22 - HVAC
EXPIRATION: NOVEMBER 2014		
SUBJECT : PRE-HEAT EXHAUST TUBE CLEARANCE

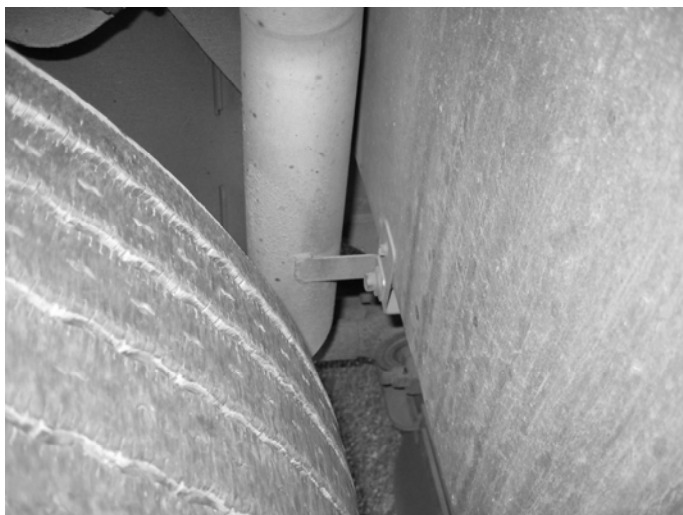
2. Inspect the clearance between the Pre-heater exhaust tube and the tag axle tire.

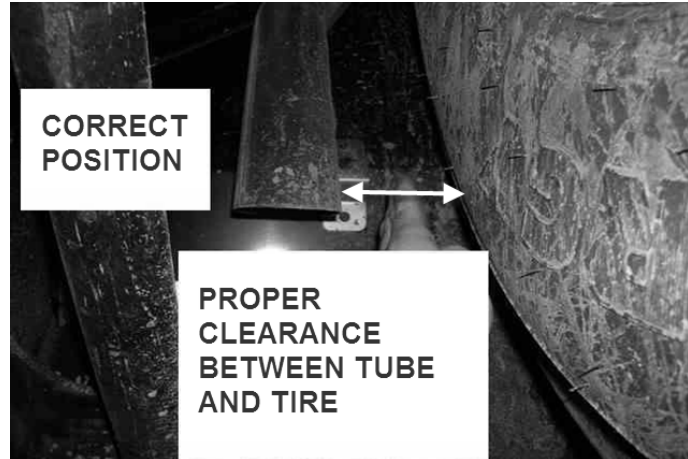
3. This is the correct position. Distance between tube and tire should be approximately 2 in.

*If the tube shows this position, end the procedure.*

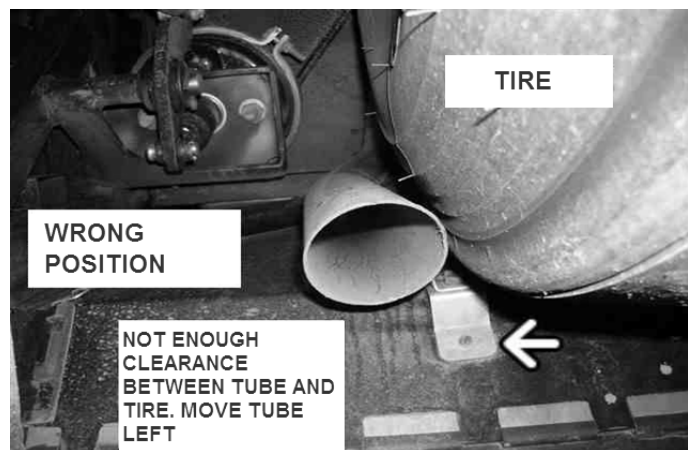
4. Any other position less than 2in between tube and tire is wrong. Proceed to the next steps.

5. Jack vehicle and dismount the rear street side tag axle wheel.

6. Remove the screws and move exhaust tube away from tire.

7. To help position the mounting bracket, there is a mark that indicates the proper mounting hole position on the plastic panel.

8. Secure at new position. Re-use mounting hardware.
