PREVOST

**WARRANTY
BULLETIN**

WB13-29

DATE :	MAY 2013	SECTION :	05 - Cooling
EXPIRATION:	MAY 2015		
SUBJECT :	LOOSENING BOLT ISSUE - COOLING FAN CLUTCH TRIPOD

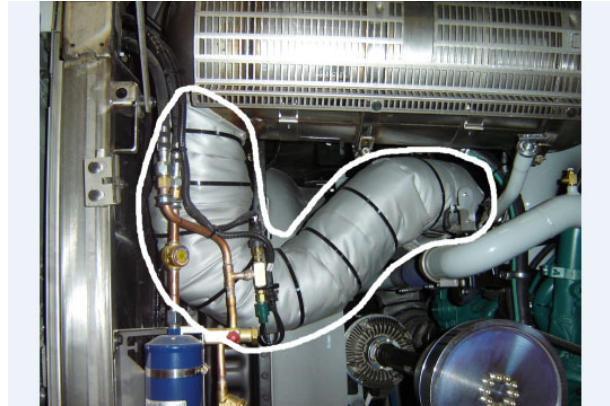
3. **H3 VIP CONVERSION SHELLS.** The section of the exhaust pipe located between the DPF and the flexible section above the turbo must be removed to gain access to the tripod upper support.

a. Clear the two (2) V-band clamps hidden under the insulating blanket at the junction with the DPF and at the junction with the exhaust flexible section.

b. Undo the two (2) V-band clamps identified on the image.

c. Unscrew the nut at the support bracket.

d. Remove this section of exhaust pipe.

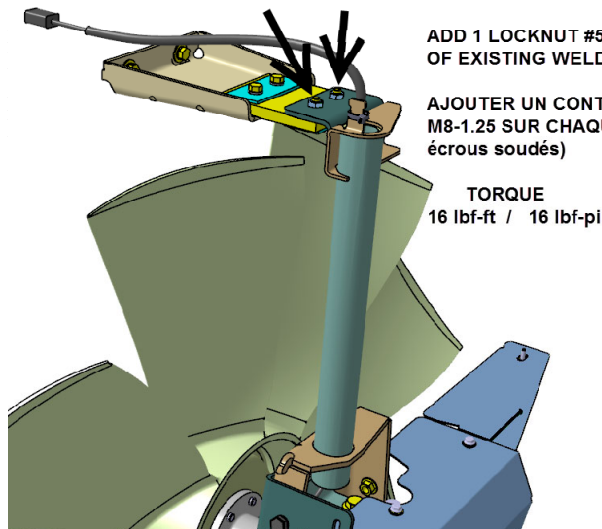
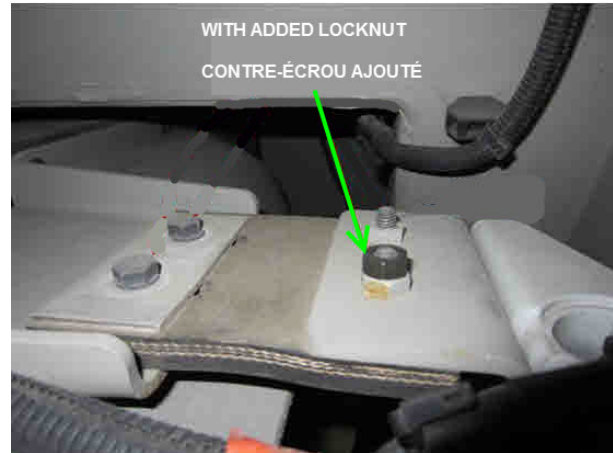
On the vehicles affected by this bulletin, a corrective measure is required due to bolts coming loose at the radiator fan clutch tripod attachment to the radiator. Bolts tend to get loose because they are tightened on a part made of rubber. Addition of four (4) locknuts (jam nuts) will prevent bolts to loosen and consequently, the radiator fan from striking the radiator core if the assembly fails.

4. **ALL TYPES.** Add two locknuts #502851 as described on the image at right. **If needed, tighten the bolt a little bit more to show more threads.**
