Warranty Bulletin

WB13-86A

Date Expiration Group No. Page
11.2013 11.2014 1(3)
BODYWORK SOFTWARE UPDATE
Volvo 9700 (B13R)

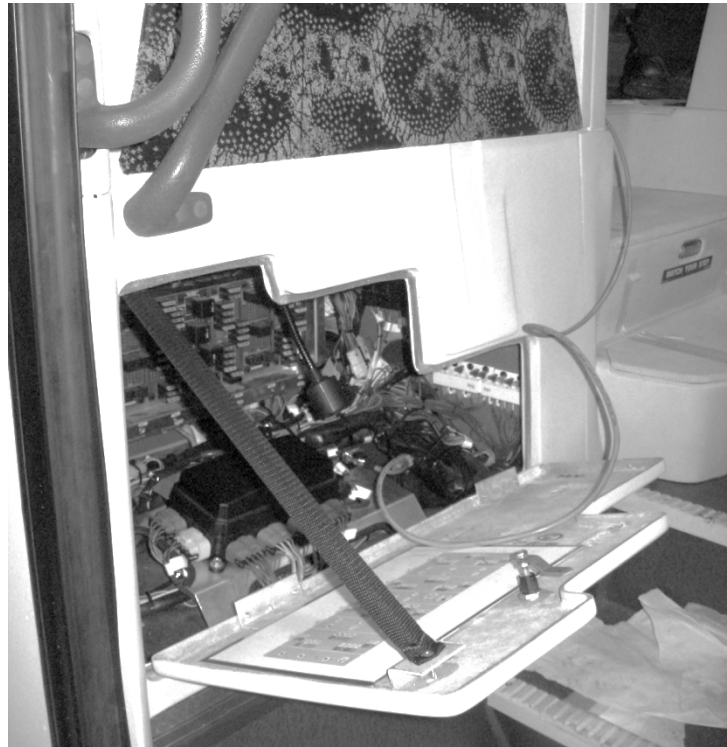
- 1) In the interior of the vehicle, open the electrical service hatch in the entrance staircase.

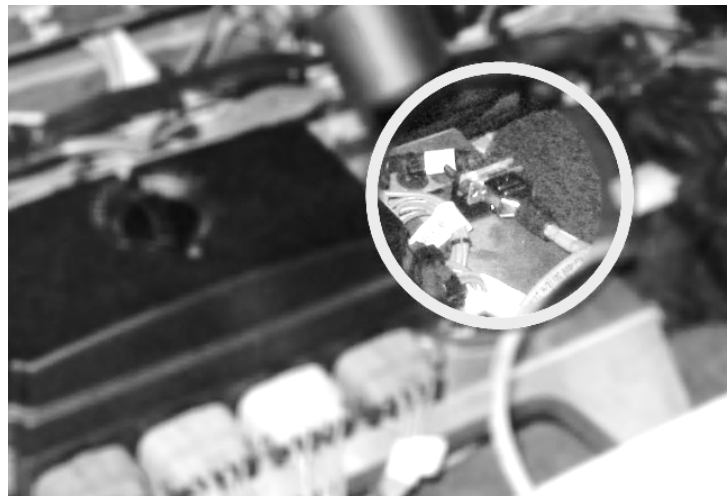
- 3) Connect your lap top to the DB9 connector on the vehicle using Prevost cable 066009.

Make a dial up connection with MasterID/MCM thru a virtual serial port adapter using a 36000bps modem.
