PREVOST

WARRANTY BULLETIN

WB15-13

DATE :	MARCH 2015	SECTION :	16 - Suspension
EXPIRATION:	MARCH 2017		
SUBJECT :	IFS LEVEL VALVE CONTROL ROD POSSIBLE CONTACT

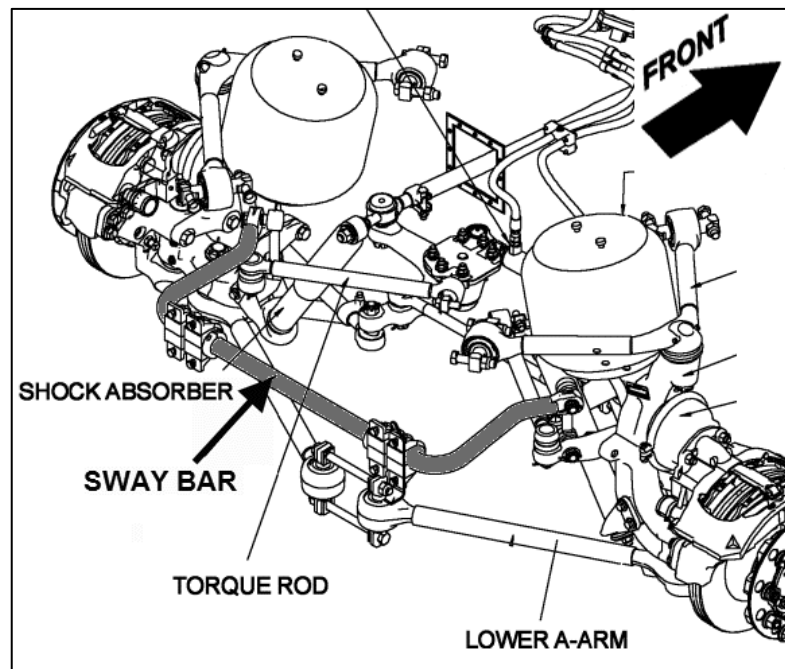
Figure 1

1. On the front axle, locate the front suspension sway bar. (Fig. 1)
