PREVOST

**WARRANTY
BULLETIN**

Wb98-26

DATE : July 1998	SECTION : 01
SUBJECT : GRINDING OF POST IN REAR ENGINE COMPARTMENT

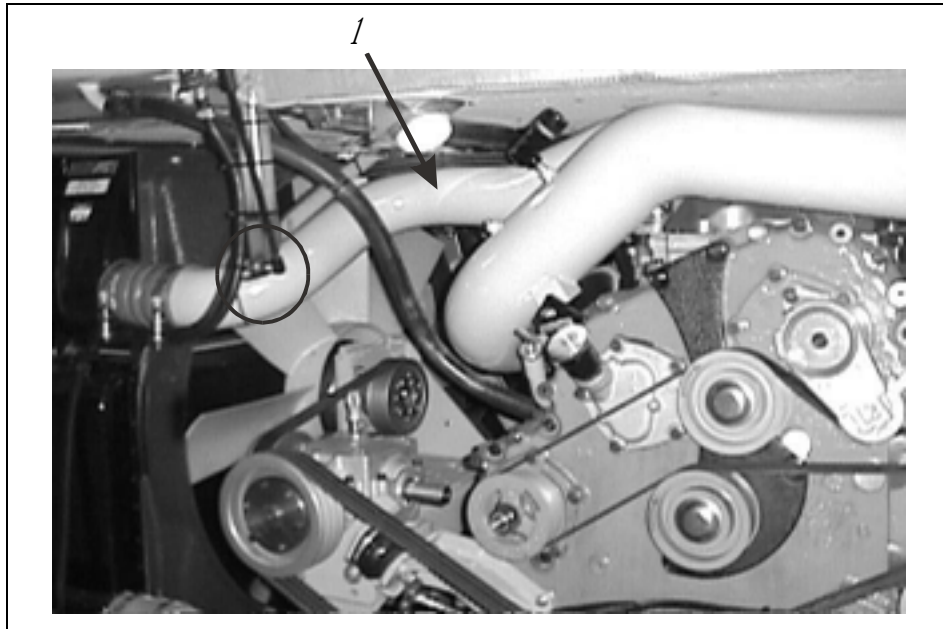
In order to avoid damaging the pipe between the air cooler and the engine, a post section must be grinded down on the above mentioned vehicles. A perforation in that pipe would reduce the air pressure and affect engine performance.

FIGURE 1: PIPE BETWEEN AIR COOLER AND ENGINE.

1. Open the rear engine compartment door.
2. Locate :
 - The pipe in between air cooler and engine (1, figure 1);
 - The metallic post holding the left hand cylinder used to open the rear engine compartment door.
3. Grind down or cut the metallic post (2, figure 2) in order to create a 1/2 in (1,5 cm) gap between the pipe (1, figure 2) and the post. If there is already a 1/2 in (1,5 cm) gap, no modification is needed.
4. If necessary, move the pipe in order to have a 1/2 in (1,5 cm) gap.

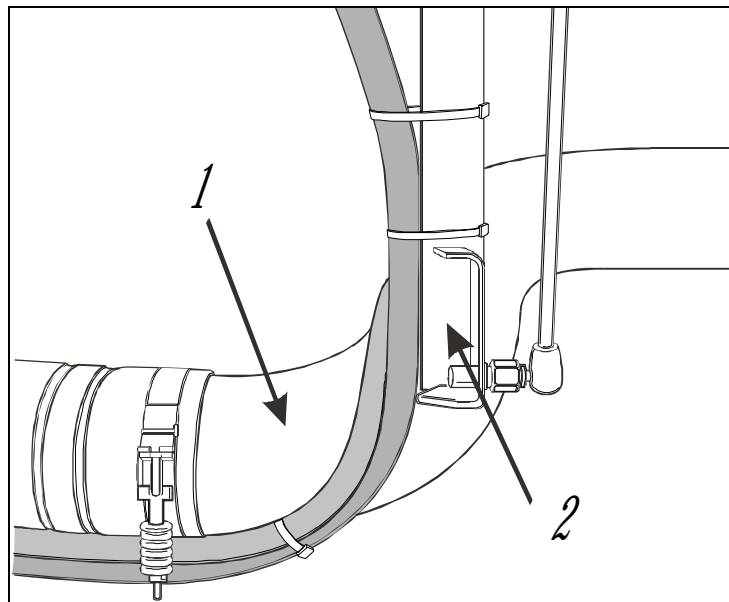
FIGURE 2: (1) PIPE BETWEEN AIR COOLER AND ENGINE
(2) METALLIC POST
