**WARRANTY
BULLETIN**

Wb99-18

DATE: SEPTEMBER 1999	SECTION: 06 - Electrical
EXPIRATION: September 2000	
SUBJECT: PROTECTION OF THE RELAYS LOCATED IN THE FRONT SERVICE COMPARTMENT

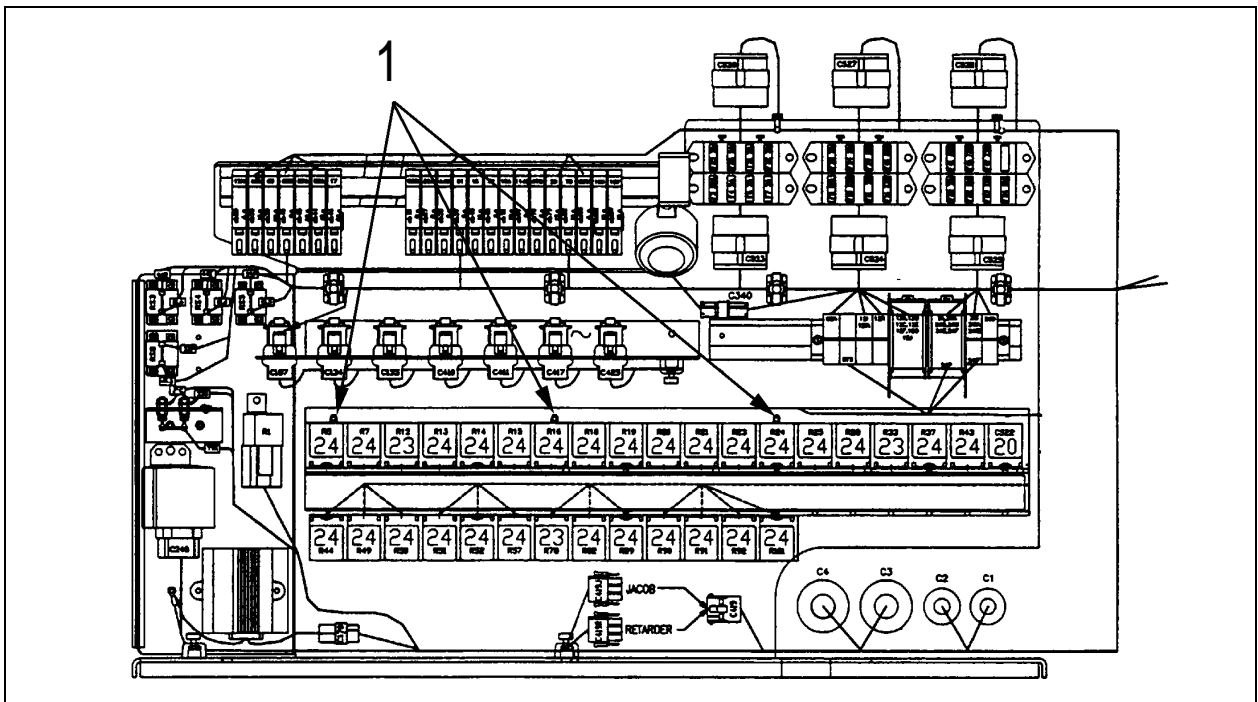
On the above-mentioned vehicles, it is necessary to add a protector to the relays located in the front service compartment in order to avoid water damaging the relays.

Figure 2: Front service compartment. (1) Screws to remove.

1. Open the front service compartment (figure 1).
2. Remove the relay support fixing screws (figure 2, item 1).
3. Install #286228 protector (figure 3) above the relays at the location shown on figure 2, item 1. Use #500641 screws and #500438 washers.
