**PREVOST**

**WARRANTY  
BULLETIN**

**WB15-55A**

DATE :	FEBRUARY 2016	SECTION :	10 - Front axle
EXPIRATION:	FEBRUARY 2018		
SUBJECT :	RADIUS ROD SUPPORT AND I-BEAM AXLE GAP INSPECTION

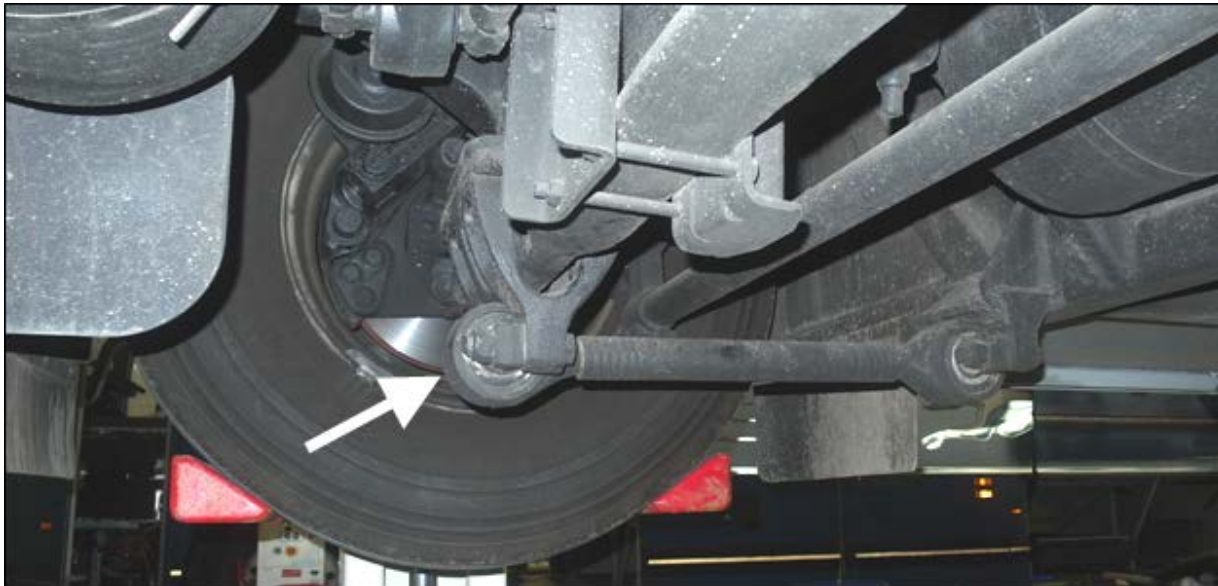
Figure 1

1. Raise the vehicle and find the radius rod supports on the front axle.

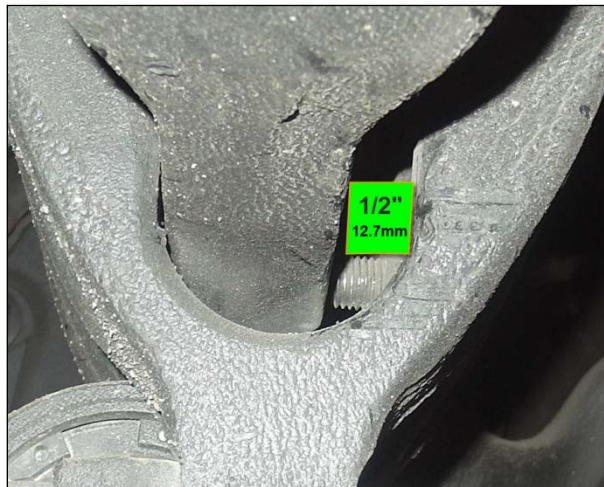
Figure 2

Attempt to insert a shim **12.7 mm** (1/2 in) thick at rear of the axle above the screw between the radial rod support, as shown. (Fig 2.)

**If the shim cannot be inserted** on the left and right support, axle is compliant. *END OF BULLETIN.*

**If the shim can be inserted,** on either one of the supports carry-on with next steps.

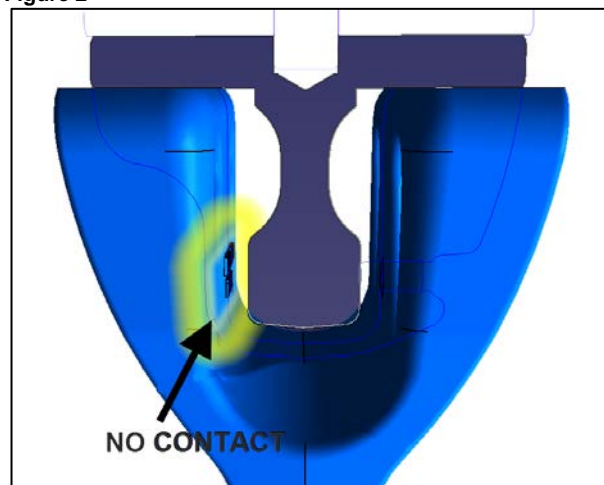
Figure 3

3. Inspect the gap between the axle and the radius rod support on the front.(Fig. 3)
4. After removing debris and protective coating, there must not be contact in zone highlighted in fig. 3.
5. Use a feeler gage set to make sure there is a gap. (Fig.3)

Use a feeler gage set to confirm there is a gap everywhere. (Fig.3)

4. Move the support to try to create a gap. (fig. 3) **Keep the support flat on the axle.**
5. Tighten the bolts and inspect the gap between axle and support.

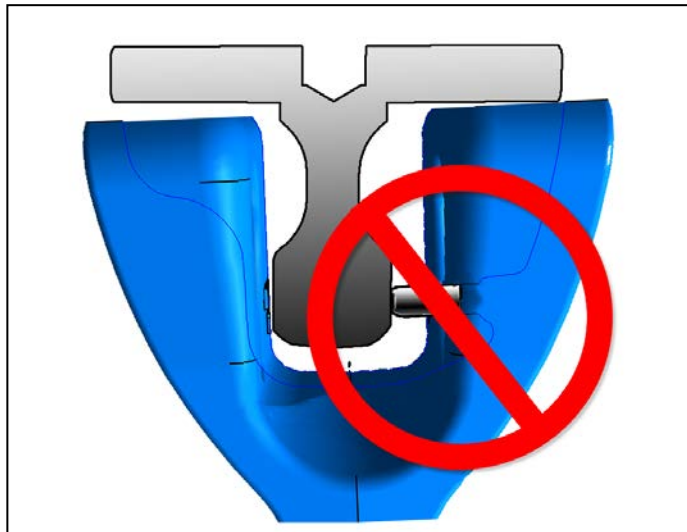
Figure 5

Do not place the support in overhang condition using the set screw as a means to create a gap. (Fig.5)

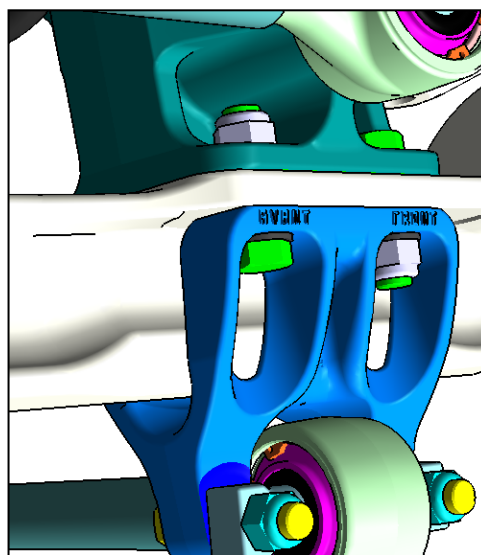
Figure 7 Left (Note different hardware arrangement)
