SAFETY RECALL

SR15-29

DATE :
 JULY 2015
 SECTION :
 10 - Front axle

SUBJECT:
 Dana Independent Front Suspension

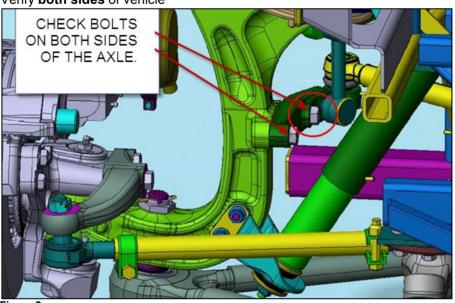
Figure 2

On the front independent suspension, inspect the bolts highlighted in fig. 2.

Verify the bolt head for the marking "OF". If present on one of the bolts, replace <u>BOTH</u> bolts

2) Verify **both sides** of vehicle

3) Replace one bolt at a time

-	Short Bolt M20 X 60 G12.9	PN 611305 QTY 2/VEH
-	Long Bolt M20 X 80 G12.9	PN 611307 QTY 2/VEH

- 4) Run a **M20 X 2.5 size tap** in the threaded section of the axle. You have to go from the back side and not the bracket side
- 5) Clean the bolt thread as well as the support thread using degreaser. Dry with compressed air.
- 6) Apply 271 Loctite or Permatex 27100 on bolt and threaded hole
- 7) Torque to 547 FT LBS, Qty: 2 per side
- 8) Apply undercoating on Bolt heads
- 9) Reinstall sway bar links. Torque to 165 lbf-ft.
- 10) Reinstall shocks. Torque to 110 lbf-ft.
- 11) If no "OF" marking on the bolts, the vehicle is Conform.
