WARRANTY BULLETIN

WB19-02A

DATE :	April 2019	SECTION :	01 ENGIN	IE
EXPIRATION:	April 2021			
SUBJECT :	ALTERNATOR	IDLER SUPPORT	REPLACEN	IENT

On the vehicles affected by this bulletin replace the idler and belt tensioner *support* on the left side (hot side) of the engine by an improved part, 011213.

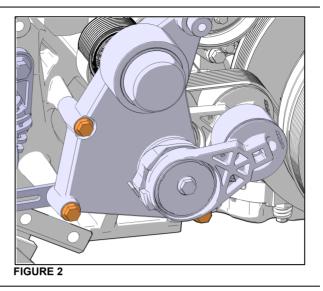
4. Remove the idler support by unscrewing the three screws. Keep hardware for reuse.

Support must be scrapped. It must not be reused on vehicles.

- 5. Remove idler and belt tensioner.
- 6. Take note of the idler position as it may be installed higher or lower on the support.
- 7. Discard support. Keep idler and tensioner. Keep hardware for reuse.
