SP22-301A

LOOSE CONNECTIONS ON ALTERNATOR CABLES - MAIN POWER COMPARTMENT

Prevost vehicles

DESCRIPTION

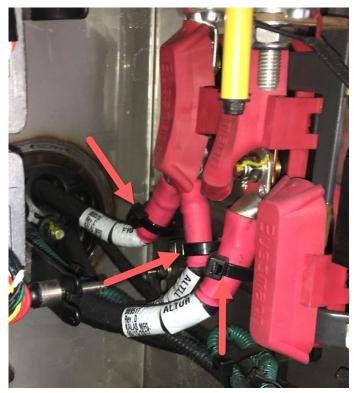
Figure 1: three cables, two connection points

1. In the main power compartment, remove the three (3) nylon ties identified on Figure 1.

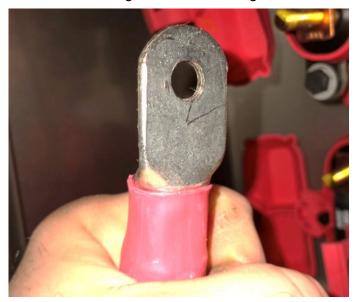
Figure 3: cable lug in good condition, no heat effects

3. Inspect the lugs, the studs and the fuse bus bars for damages. **If heat damage is evident**, **STOP AT THIS STEP** and contact immediately the Prevost field service manager and NYCT representative to further inspect the damage.

Example of damage: wear, heat effect, damaged parts, no coating on bus bars where the terminal sit or glue residue, among others.

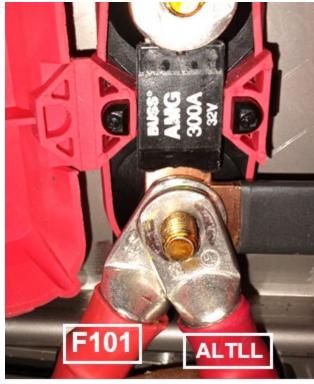
Figure 5: 1st connection point

4. **FIRST CONNECTION POINT** (Figure 4). Reinstall the components in the proper sequence i.e. fuse bus bar, cable lug F101, cable lug ALTLL, washer and then the nylon insert nut (Figure 5).

5. Secure the two (2) cable lugs using one (1) washer no 5001341 and a nylon insert nut no 5001787. Tighten to a torque of 100 lbs-in.

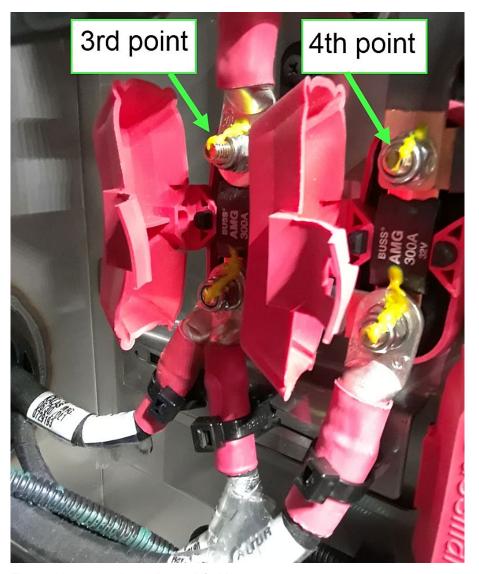
Figure 11: connection point: 3rd & 4th

12. **3RD & 4th CONNECTION POINTS.** Repeat the same process for the 3rd & 4th connection points located on top of the same two (2) fuses. See Figure 11.
