PREVOST

WB23-23

SUBJECT: EXHAUST LEAK

H3-45

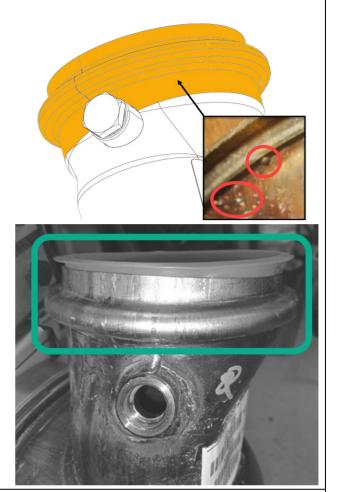
X3-45 1. Locate the DPF outlet. 2. Check if you see exhaust leak see picture. If yes go to next step. Otherwise, the procedure is complete. 3. Remove the clamp.

9. Grind off welding spatter of the DPF output.

- 4. Install the new gasket 21095726.
- 5. Reinstall the clamp with a torque of 100 lb-in.
- 6. Reattach the blanket.
