WB24-09

BULLETIN

SUBJECT :
 FLECTRONIC MIRROR LENS CLEANING

CT: ELECTRONIC MIRROR LENS CLEANING SYSTEM INSPECTION

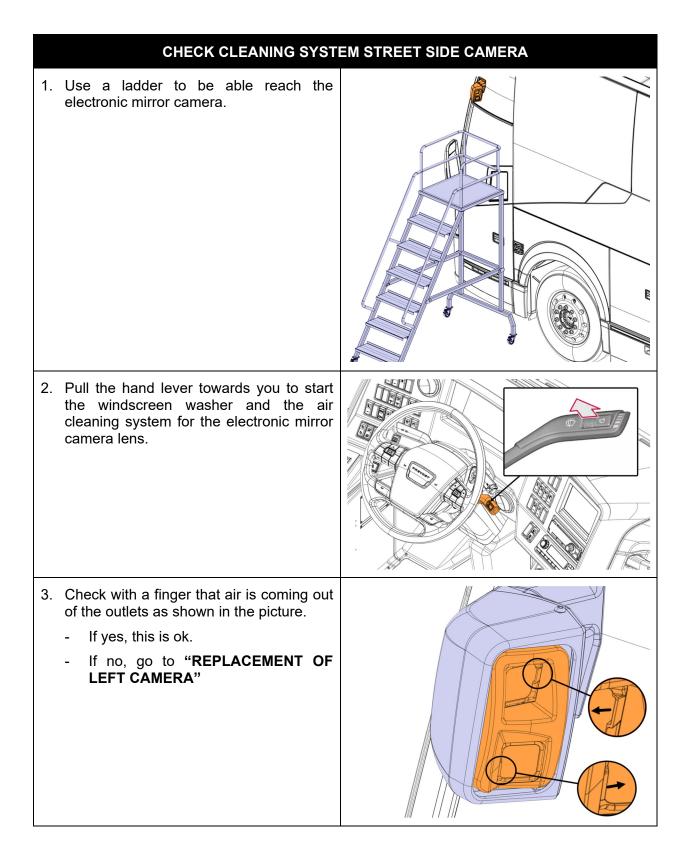
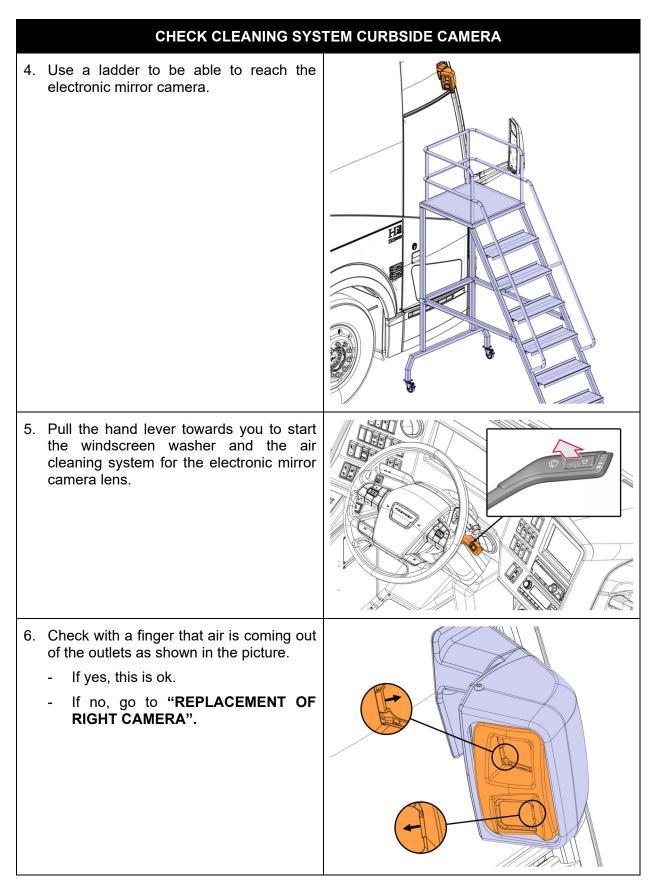
On the vehicles affected by this bulletin, the electronic mirror lens air-cleaning system may not work.

REPLACEMENT	OF LEFT CAMERA
1.	Remove the cover 492119 and screws 5002236 (3x).	
2.	Disconnect the harness 0610486 from camera 901812.	A222W.A A143 A143 A141 A222W.B
3.	Disconnect air hoses 140495 (2x) from the camera.

4.	Remove camera assembly from the base 492117 and the screw 5001912 (1x) and the lock washer 5001161 (1x).	
5.	Remove the pin 502006 (1x) from the base 492117.	
6.	Remove the camera assembly 901812 from the support 492118 and screws 5002245 (4x) and flat washers 502573 (4x).	492118 901812 901812 502245
