WB23-38

WARRANTY

SUBJECT :
 UREA HARNESS REPLACEMENT

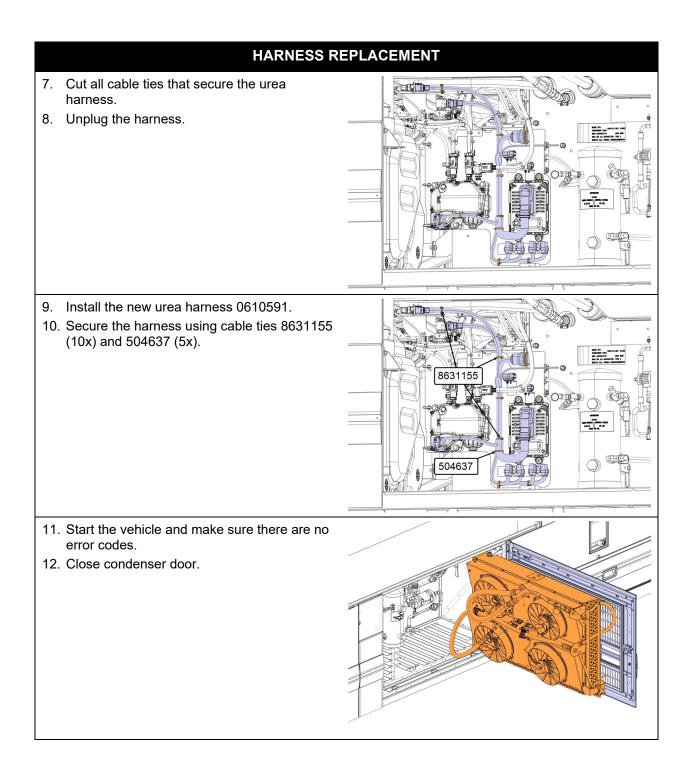
On the vehicles affected by this bulletin the urea harness possibility needs to be replaced to avoid oxidation.

111 4. Locate connector A137A. II)De A137A 5. Remove eight inches of the loom from connector A137A. 6. Verified if you have wire with a splice see the picture. If yes, go to the next step. _ If no, reinstall the loom and secure the cable to complete the procedure.
