PREVOST

MAINTENANCE INFORMATION MI12-40

DATE : OCTOBER 2012	SECTION : 06 - Electrical
SUBJECT : LOAD DUMP PROTECTION 50DN ALTERNATOR

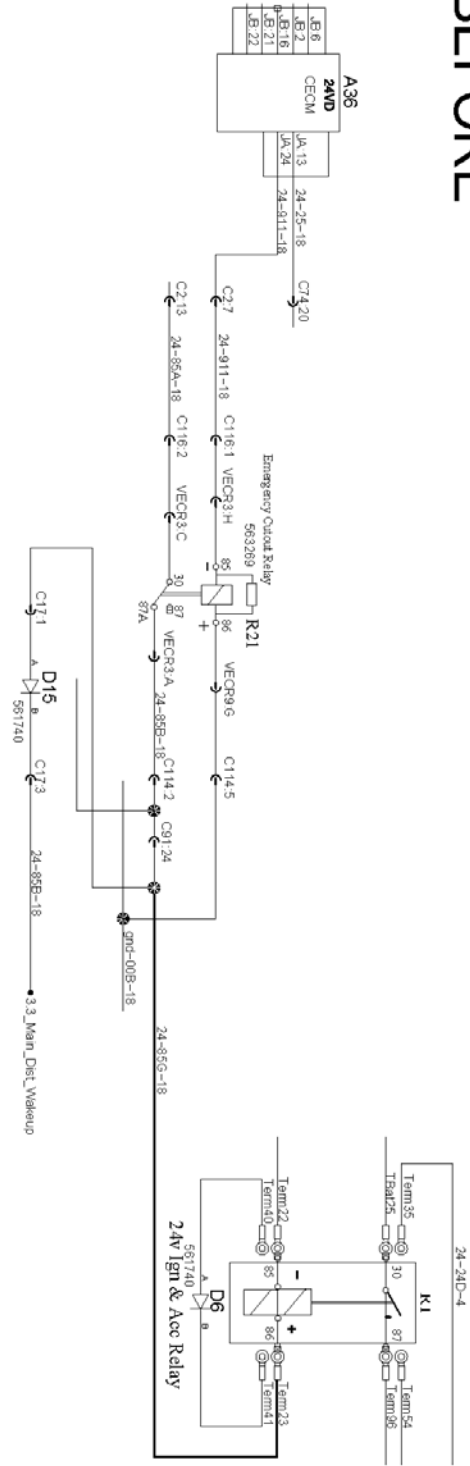
BEFORE

On the vehicles affected, the Delco 50DN alternator may generate a voltage variation when engine is shutting down. A new circuit and a time delay function can be added to the system to provide protection.
