## MAINTENANCE INFORMATION

Mi98-36

DATE : August 1998	SECTION : 22
SUBJECT : Improvement of the Condenser Fan Circuit

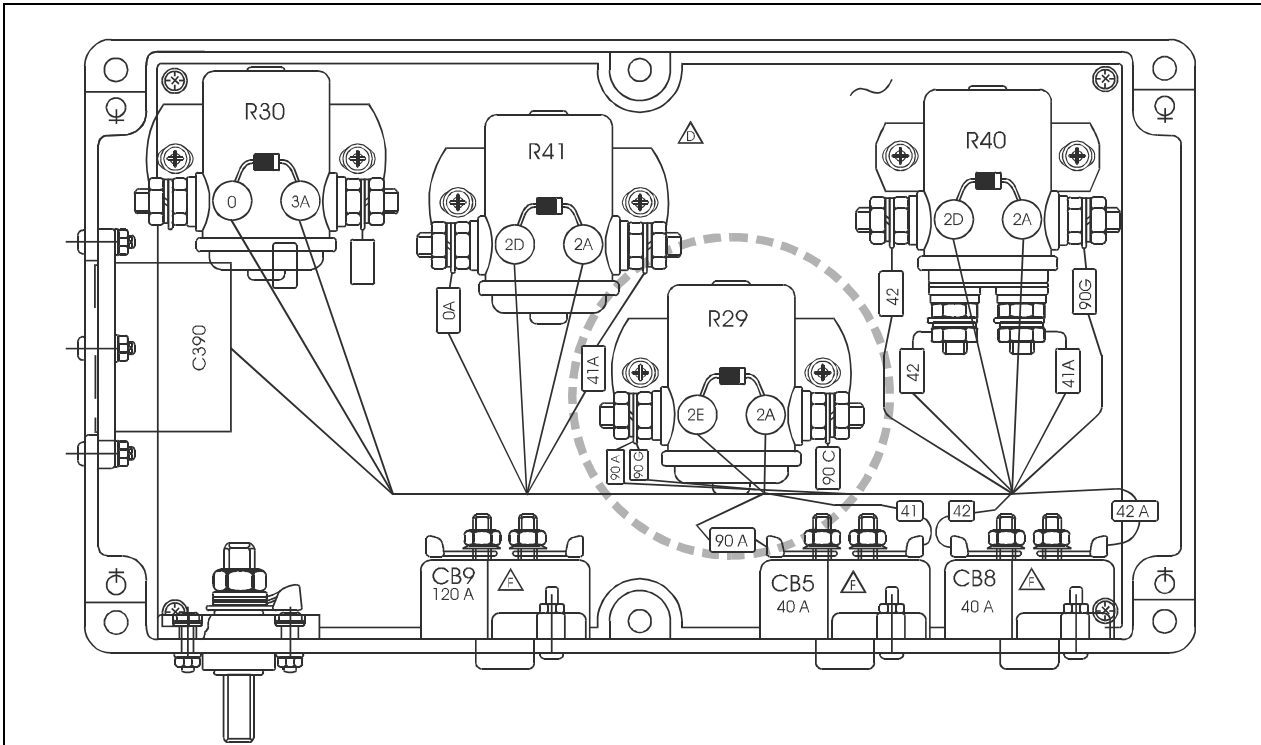
In case of a R29 relay failure, one of the two fan motors can be kept working by modifying the electrical circuit of the condenser fan.

**Figure 2:** Initial aspect of relay R29 in A/C junction box.

2. Find the R29 relay in the A/C junction box (see figure 2);
3. Remove wire 90G from relay R29 and relocate it on the other R29's terminal (on the side of wire 90C). The result of this change is shown on figure 3;
4. Put lid back and close the condenser compartment door. Replace the former electrical diagram by the new one given in the appendix.

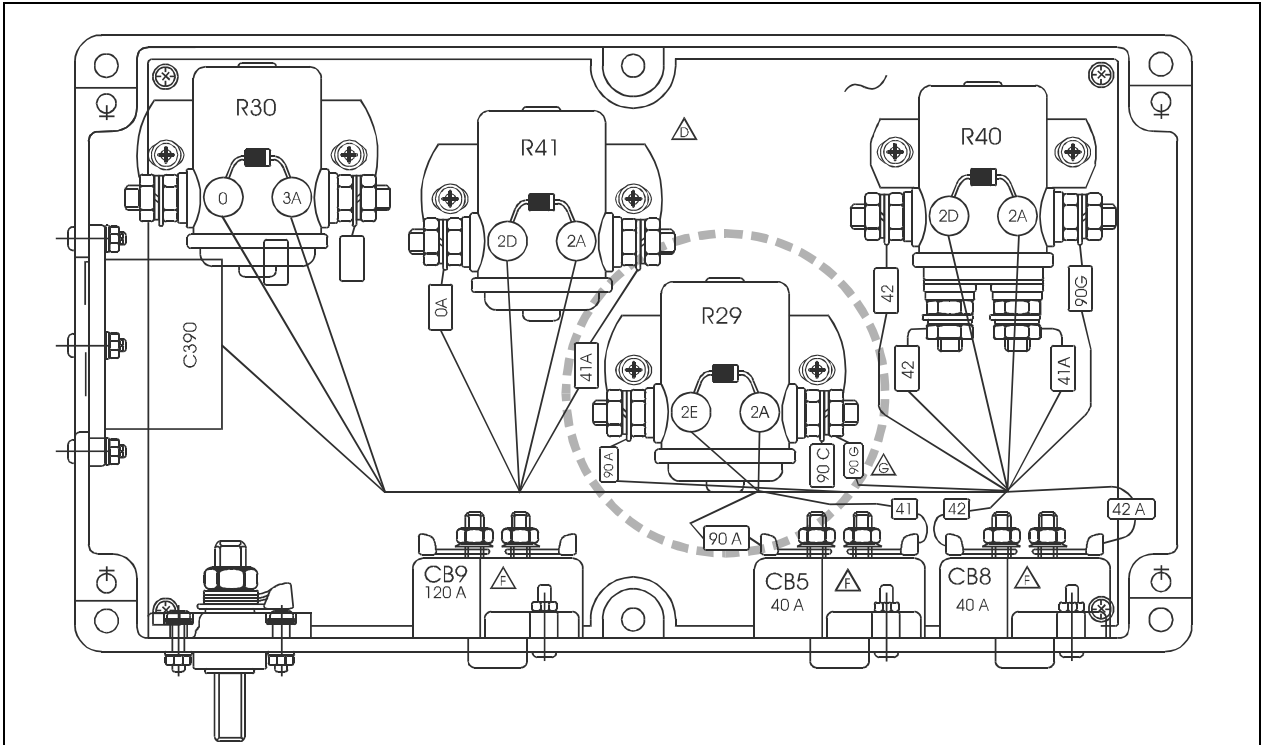
**Figure 3:** Final aspect of relay R29 in A/C junction box.
