SAFETY RECALL

Sr12-20

SUBJECT: AUTOMATIC FIRE DETECTION AND SUPPRESSION SYSTEM (AFSS) - REROUTING LINEAR THERMAL

DETECTOR (LTD)

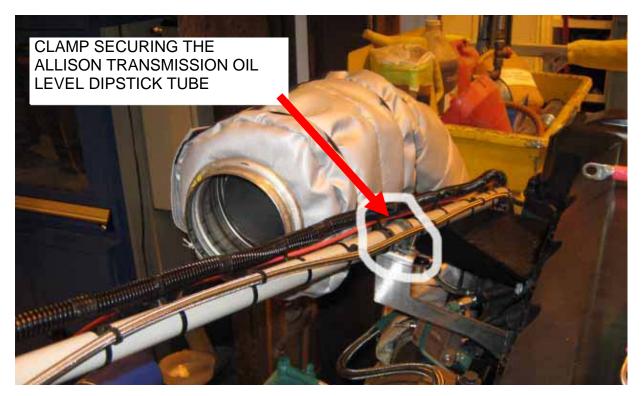
Engine turbocompressor side

Rubbing of the linear thermal detector (red cable) against the clamp securing the Allison transmission oil level dipstick tube is likely to happen.
